ROOF INSPECTION REPORT

4-11-2003

Building located at Old Manchester Road * Raymond, NH
Building used for Elementary School
Owners identification of area or building # Lamprey River Elementary School * Built in 1976
Exterior wall construction: Masonry Wood Steel Other

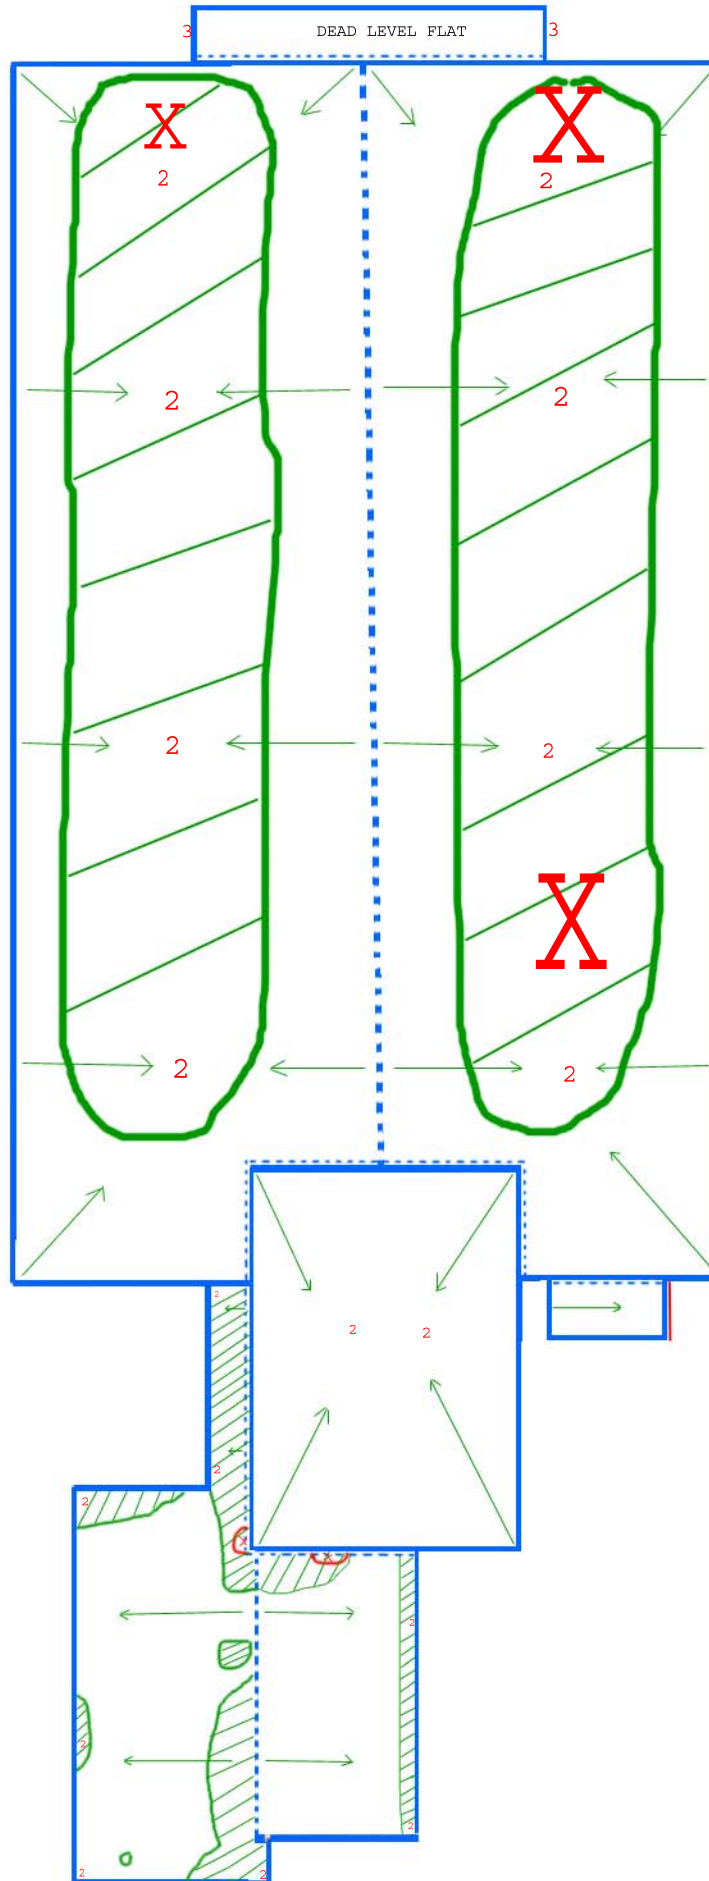
Subsurface moisture

2 Drains

3 Overflow Scuppers

X Roof deck repairs needed

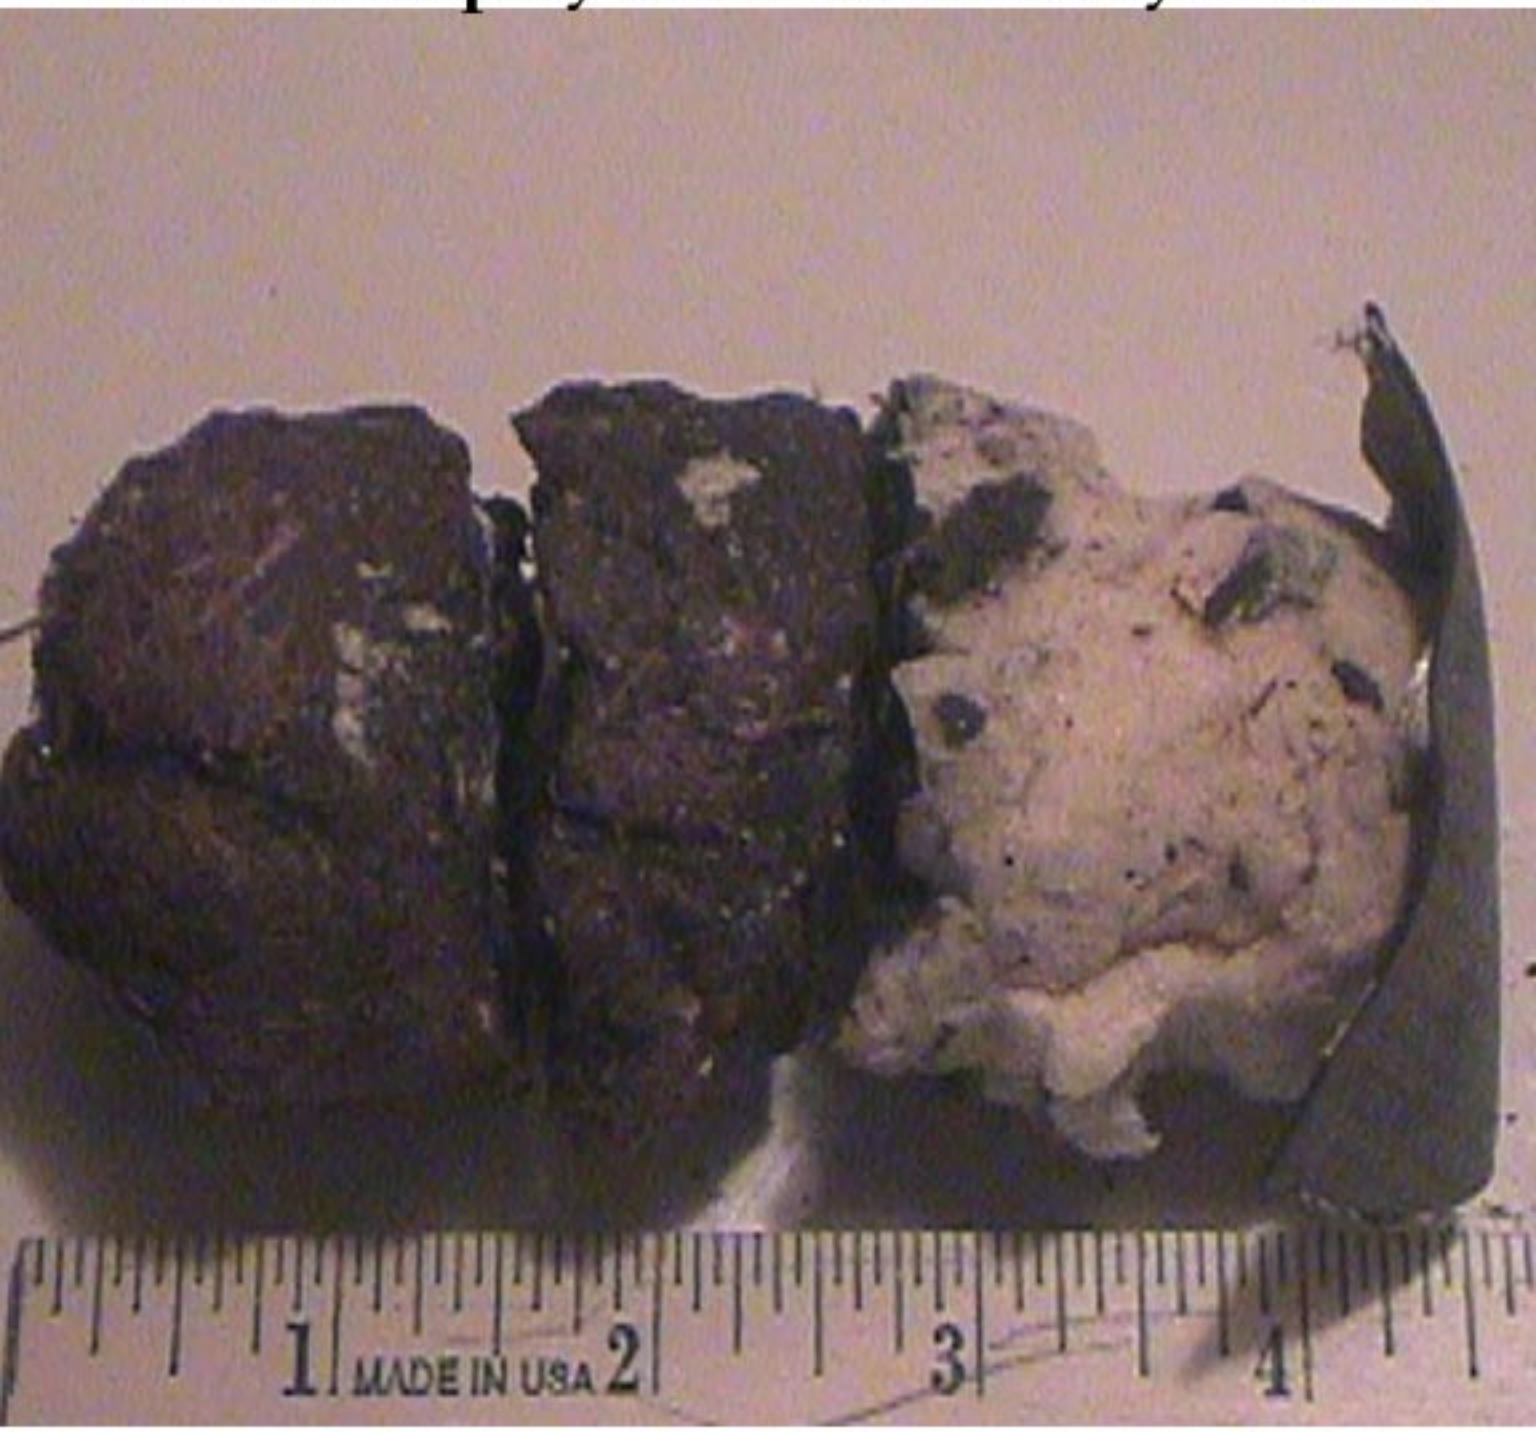
There are clearly 3 roofs on the Lamprey river Elementary School. Two built-up roofs and one thin membrane roof. With the flood coating and stones, the 2 built-up roofs are over 2 inches thick. Add the 2 inches of wood fiber insulation not included in this sample and you have +or- 6 inches of roof on the Lamprey River Elementary School.
