**Bluestone, Inc.**

## ROOF INSPECTION REPORT

10-19-2005

Building located at Carroll County Complex  
Building used for Nursing Home  
Owners identification of area or building # Mountain View Nursing Home  
Exterior wall construction: X Masonry    Wood    Steel    Other

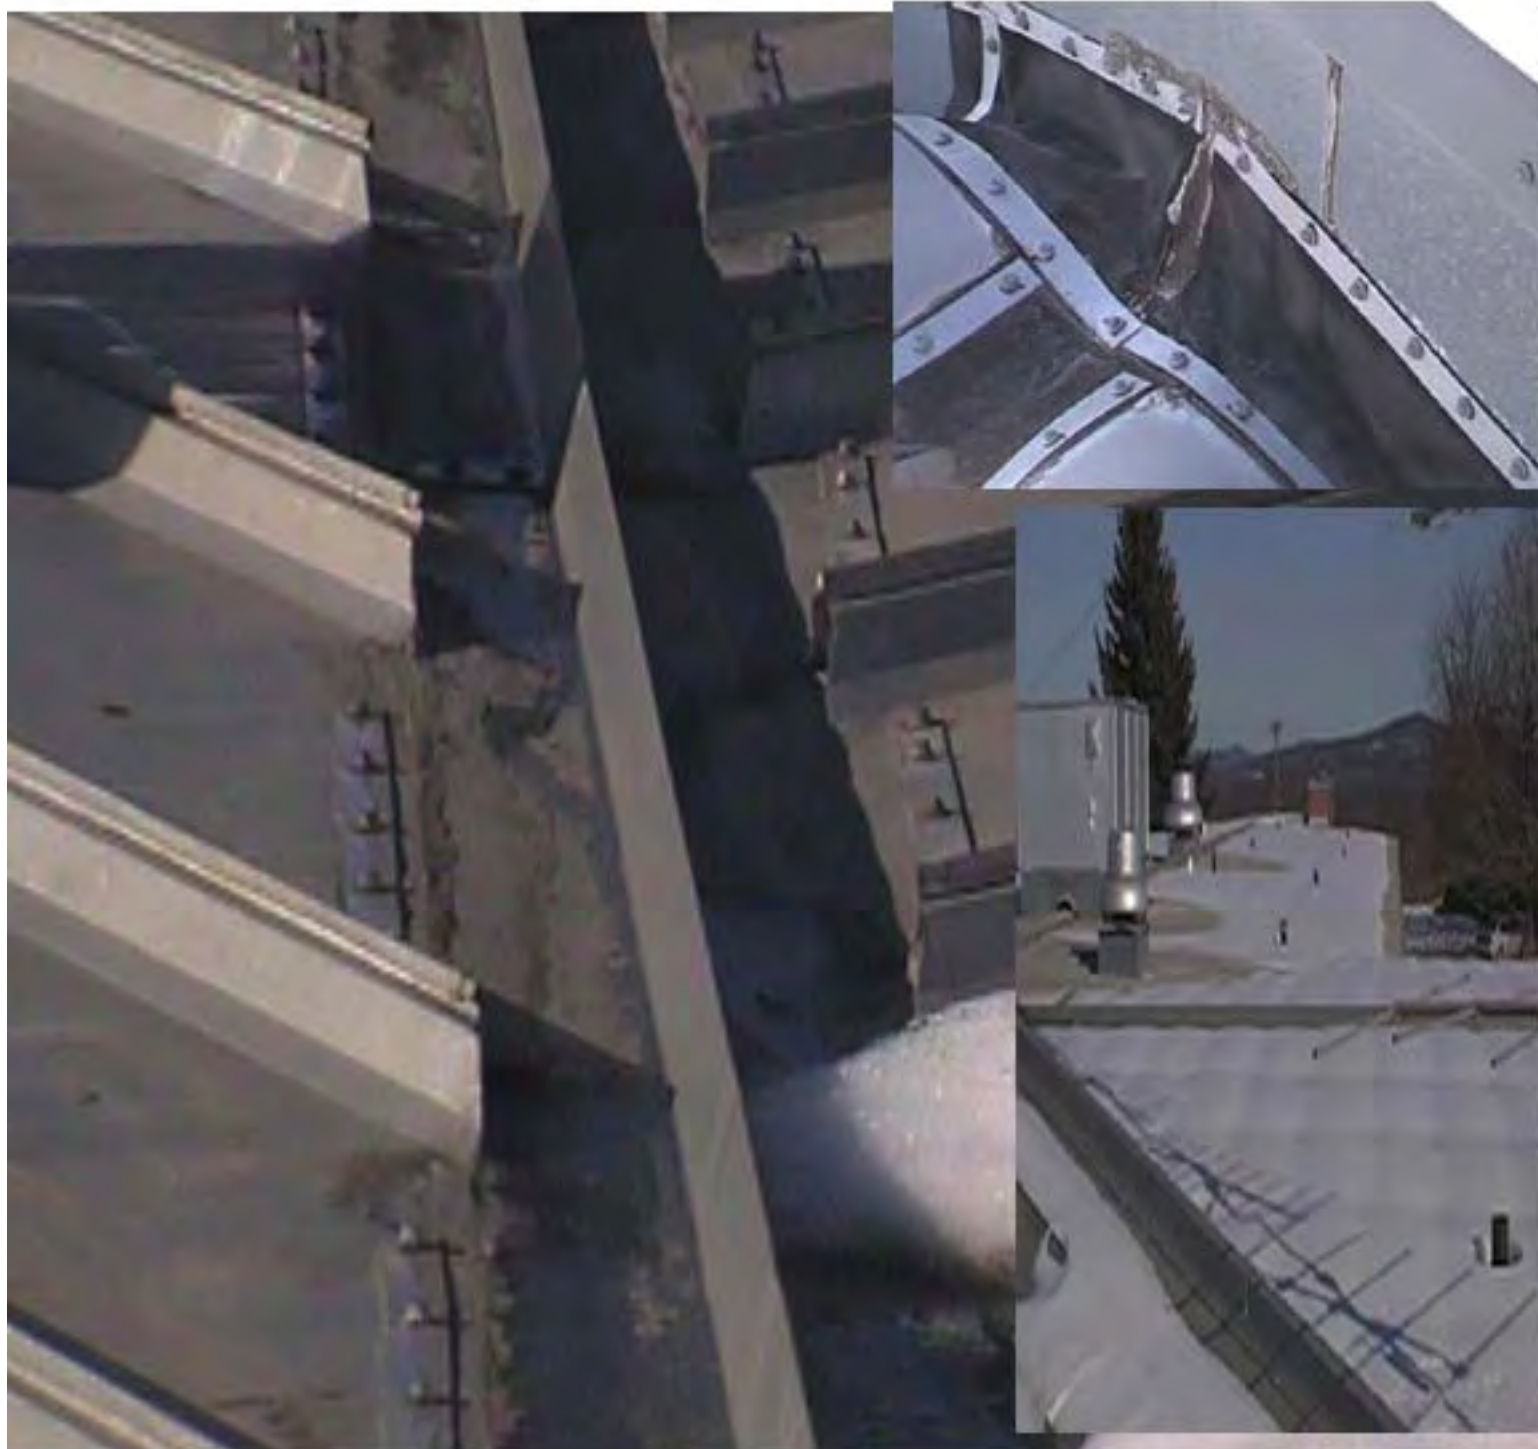
**Your metal roof has hundreds if not thousands of holes in the roof plugged by screws that are working their way loose. The good news is that it can be fixed.**

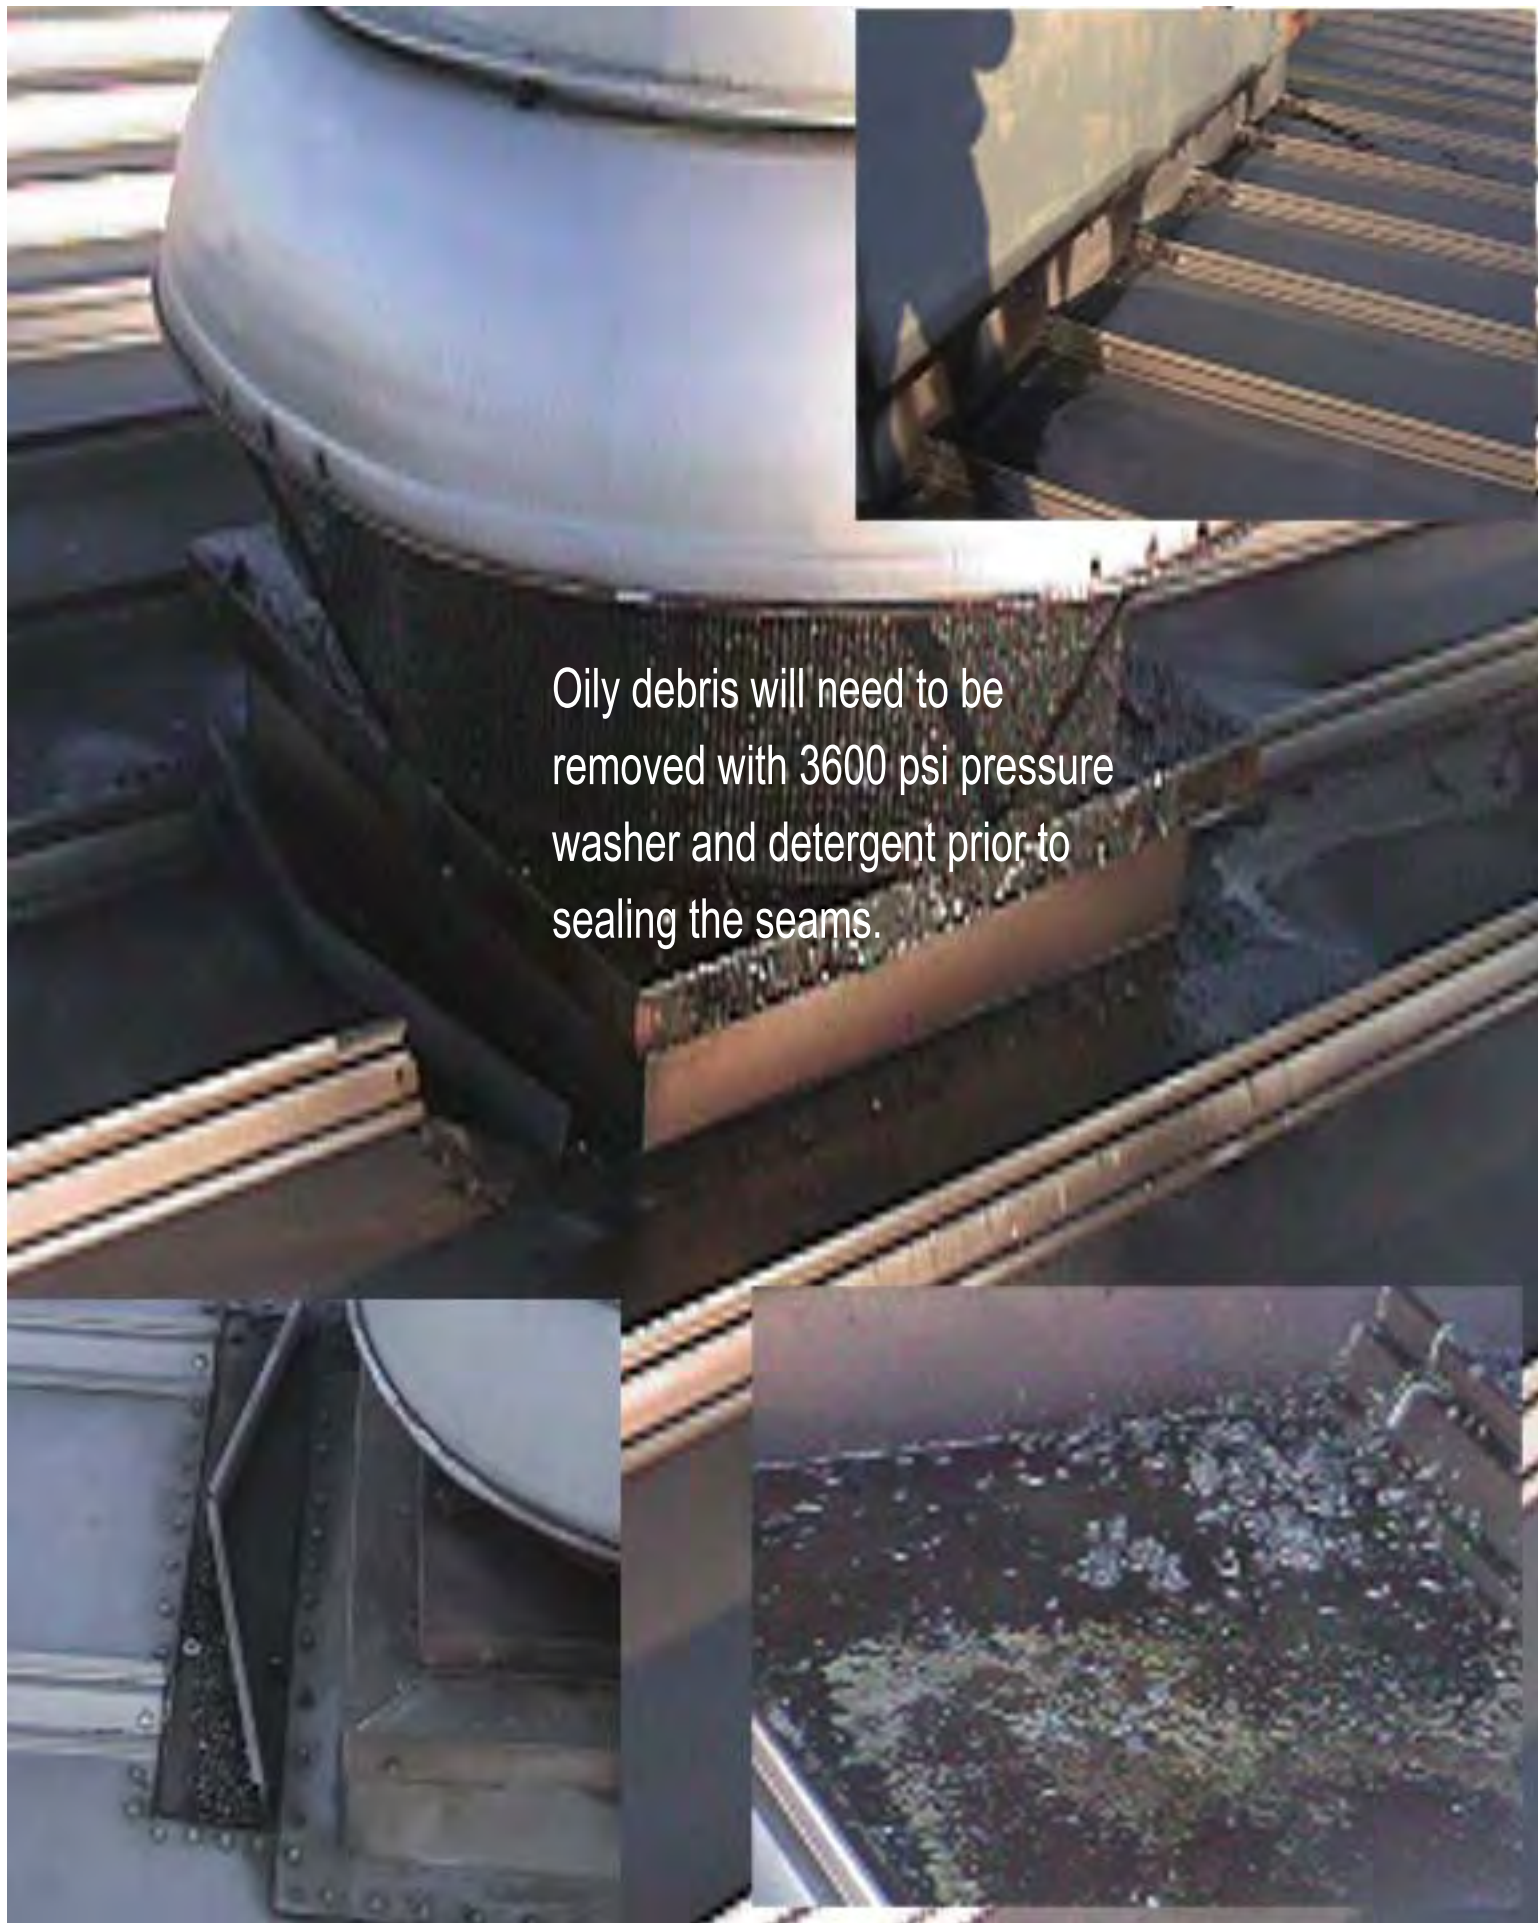
Oily debris will need to be removed with 3600 psi pressure washer and detergent prior to sealing the seams.

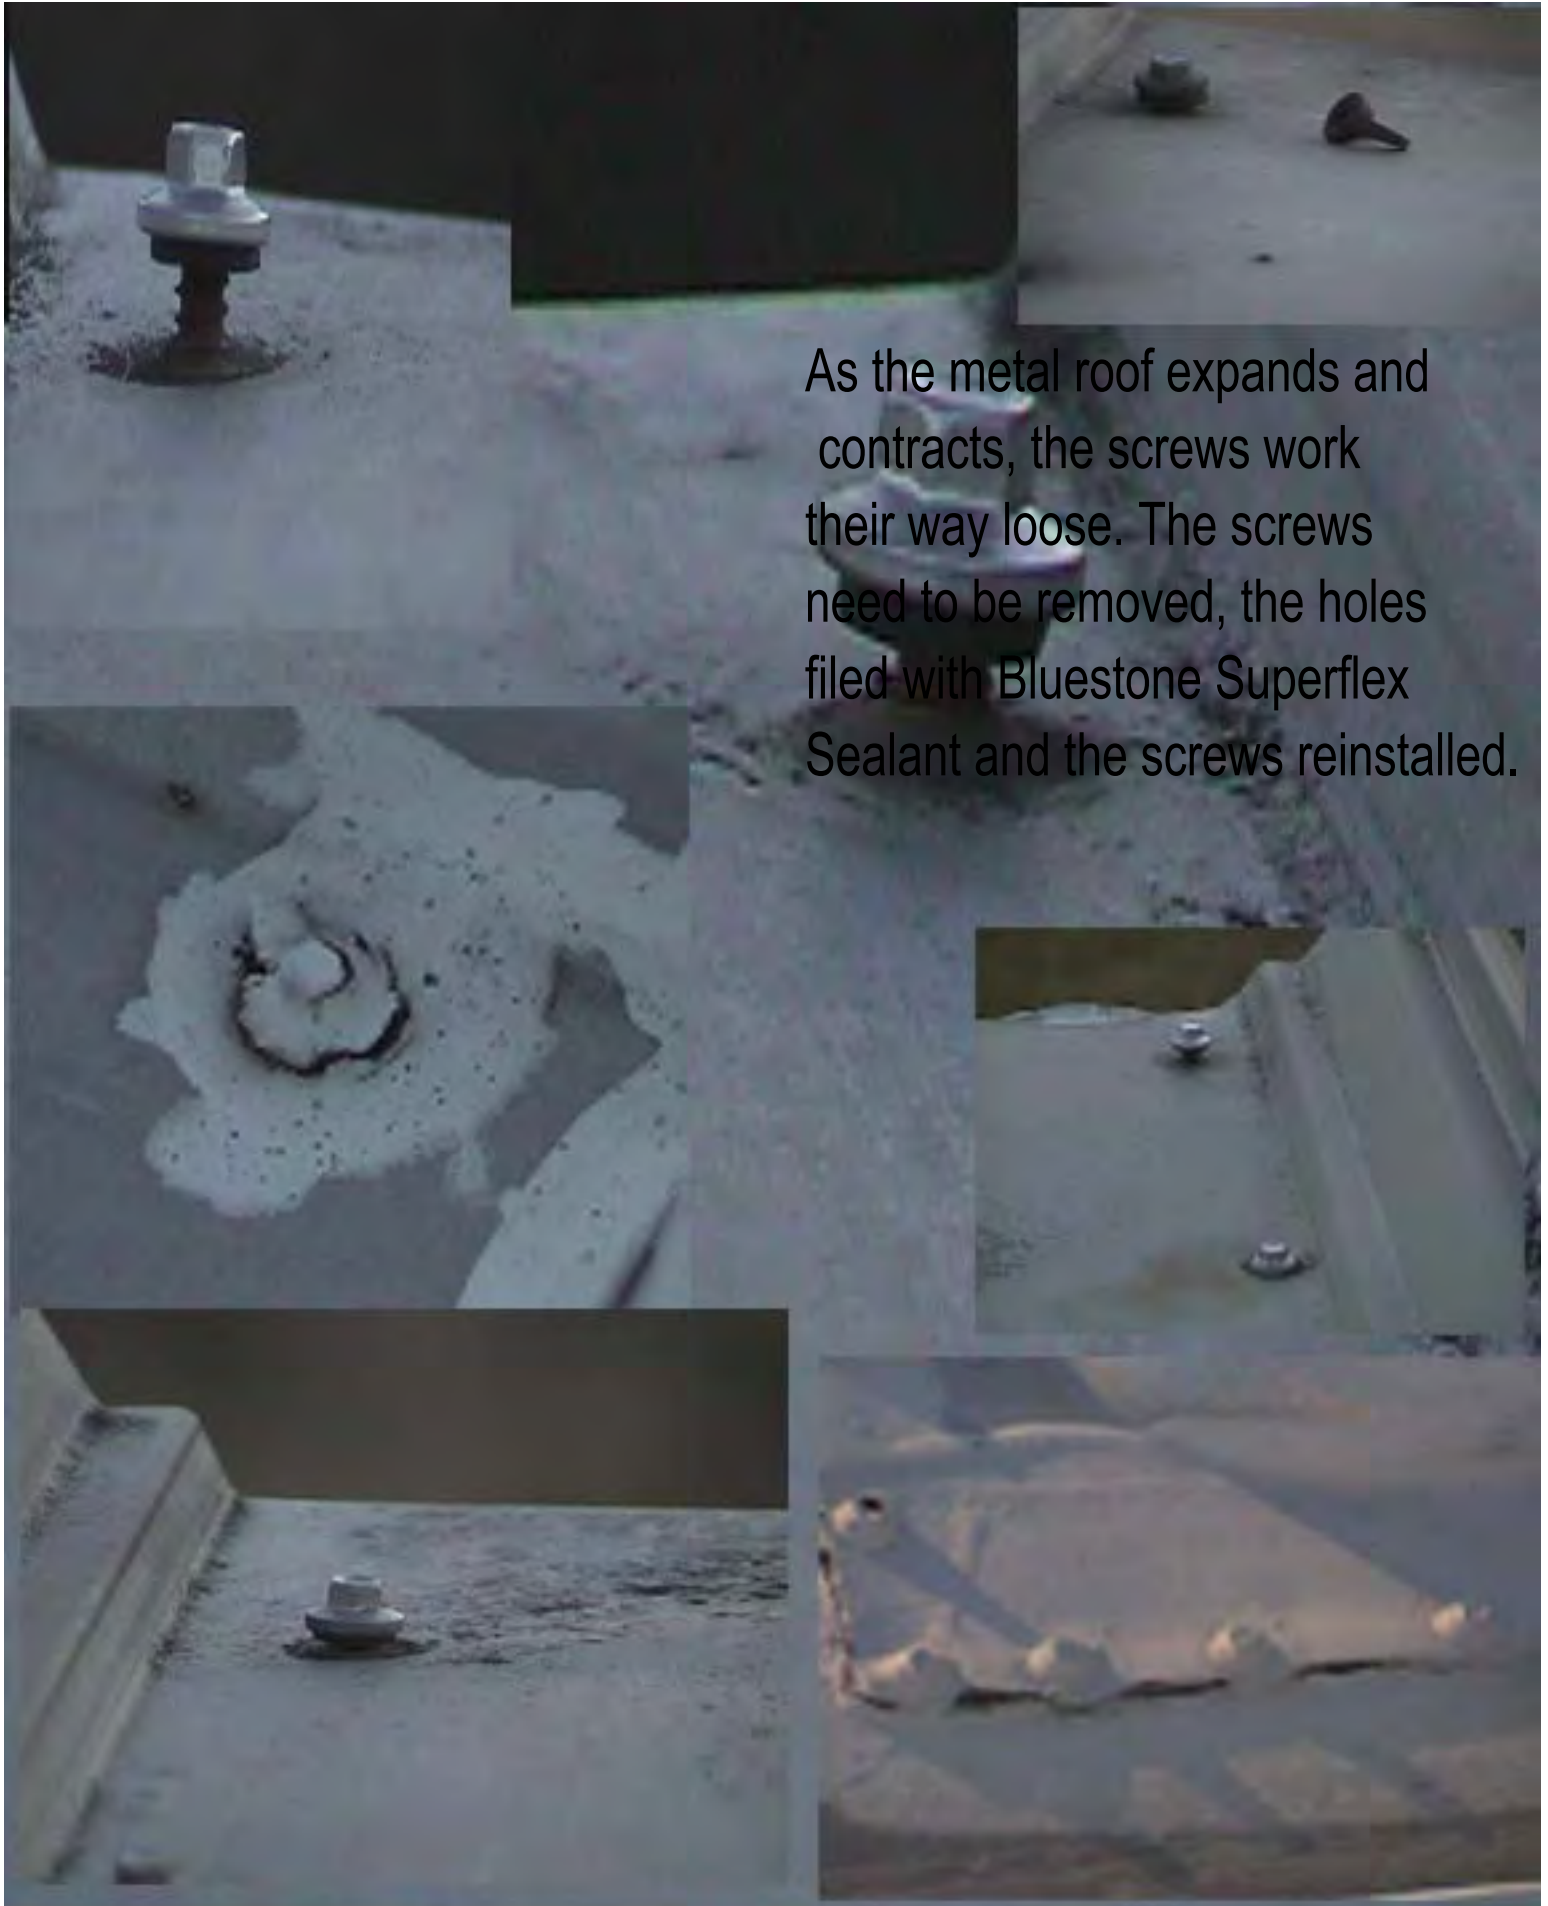
As the metal roof expands and contracts, the screws work their way loose. The screws need to be removed, the holes filed with Bluestone Superflex Sealant and the screws reinstalled.

The screws need to be removed, the metal panels lifted, Bluestone Superflex Elastomeric Sealant applied and the screws reinstalled.

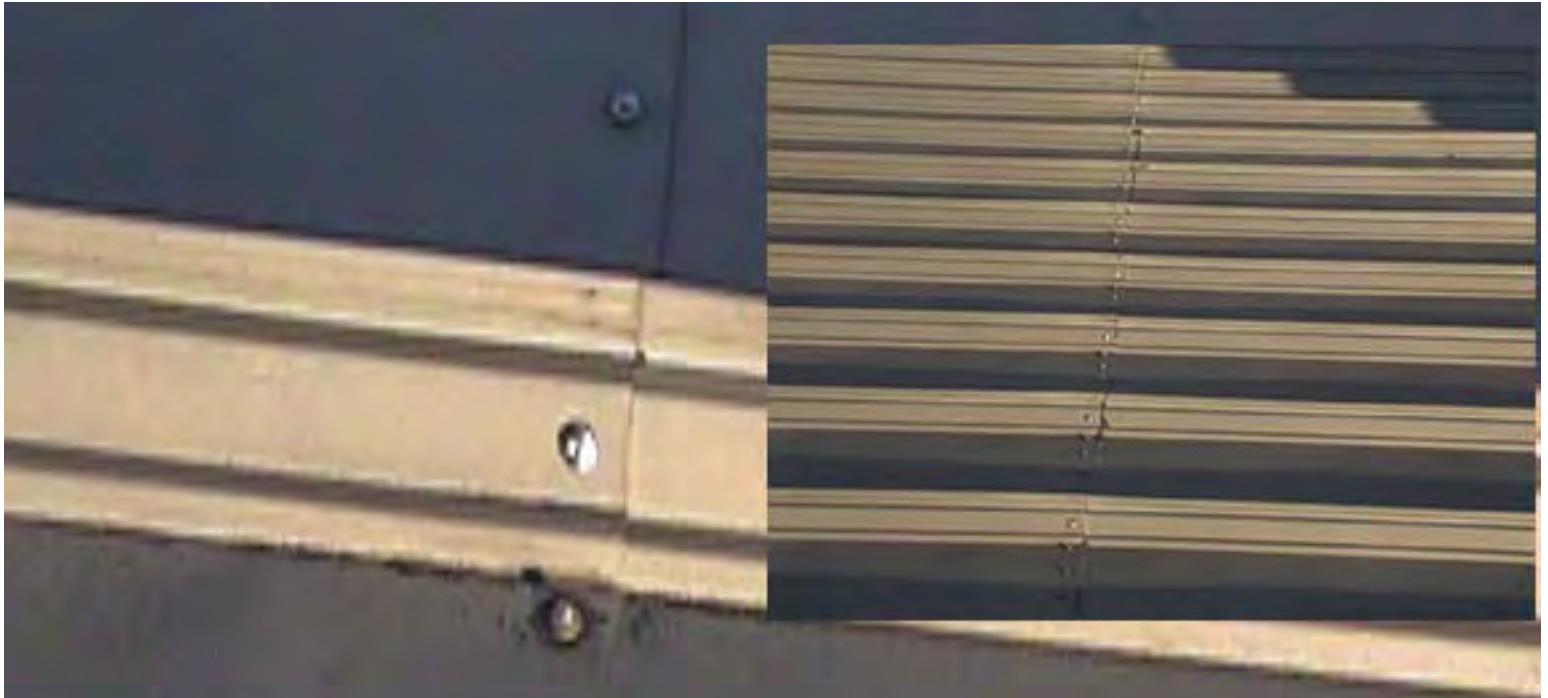
The field of the roof looks good.  
However, water is seeping in  
through loose screws.
