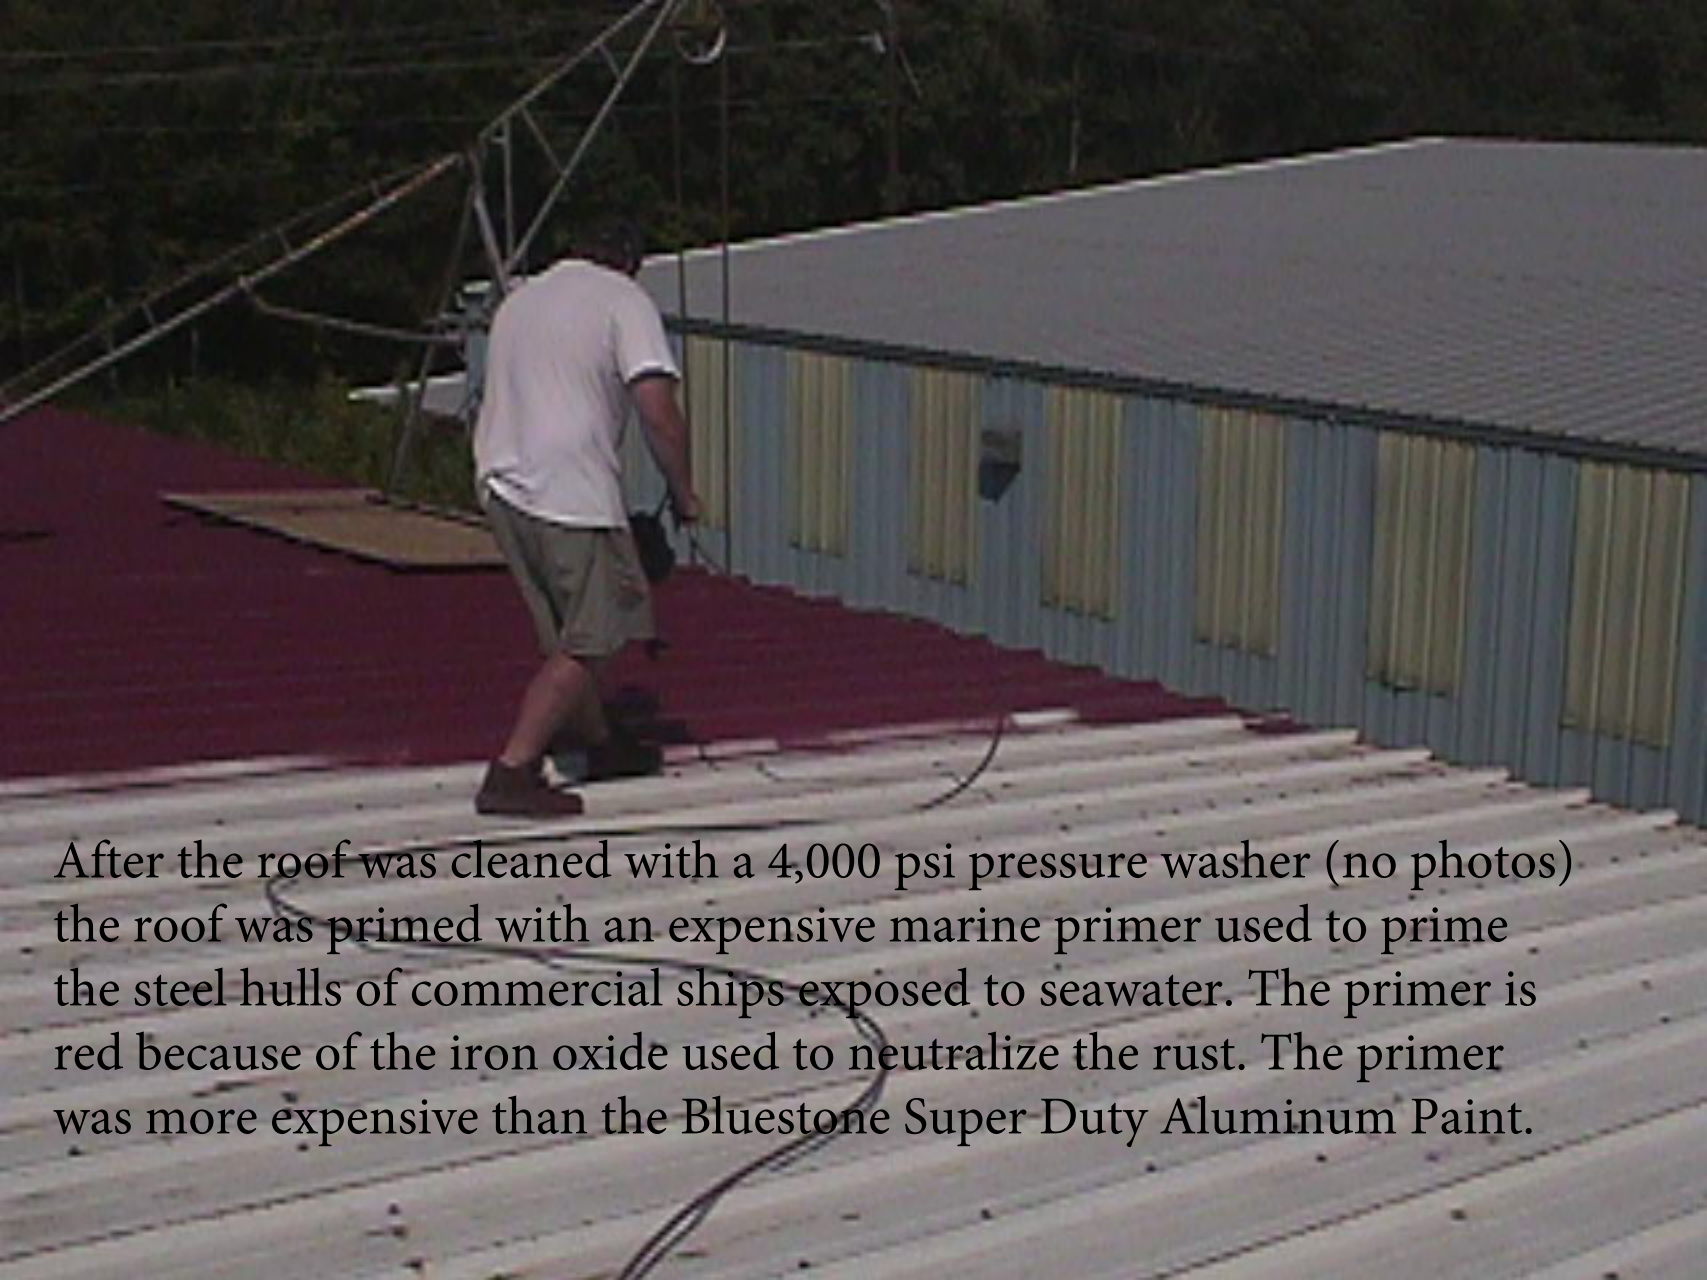
After the roof was cleaned with a 4,000 psi pressure washer (no photos) the roof was primed with an expensive marine primer used to prime the steel hulls of commercial ships exposed to seawater. The primer is red because of the iron oxide used to neutralize the rust. The primer was more expensive than the Bluestone Super Duty Aluminum Paint.
