**Bluestone, Inc.**

## ROOF INSPECTION REPORT

10-19-2005

Building located at Carroll County Complex  
Building used for Nursing Home  
Owners identification of area or building # Mountain View Nursing Home  
Exterior wall construction: X Masonry    Wood    Steel    Other

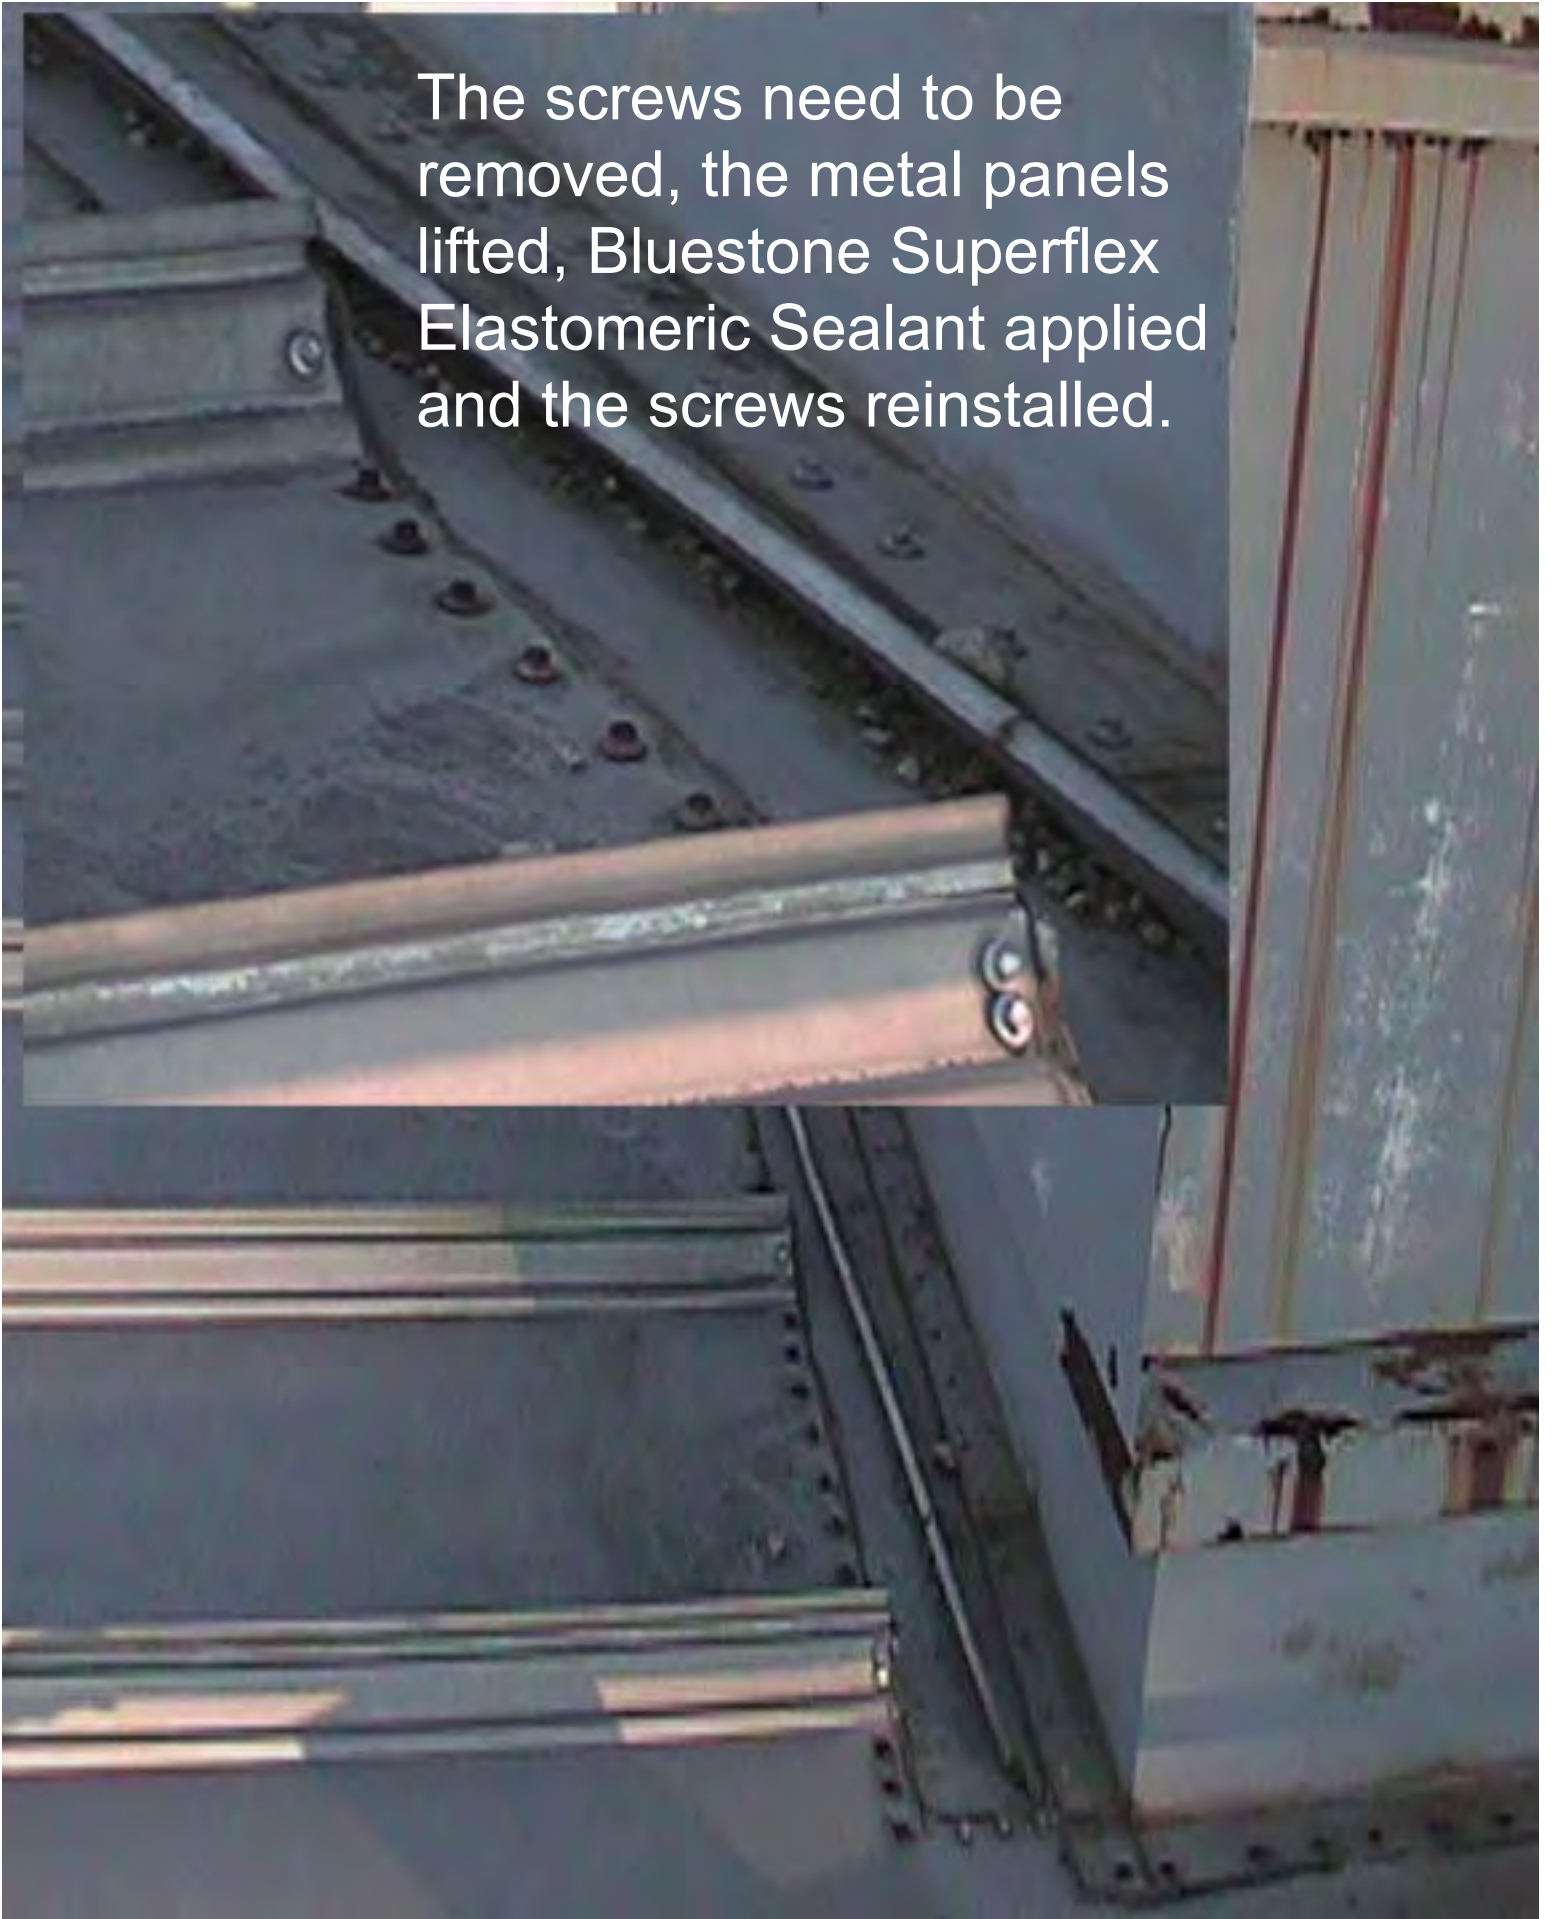
Oily debris will need to be removed with 3600 psi pressure washer and detergent prior to sealing the seams.

As the metal roof expands and contracts, the screws work their way loose. The screws need to be removed, the holes filed with Bluestone Superflex Sealant and the screws reinstalled.

The screws need to be removed, the metal panels lifted, Bluestone Superflex Elastomeric Sealant applied and the screws reinstalled.

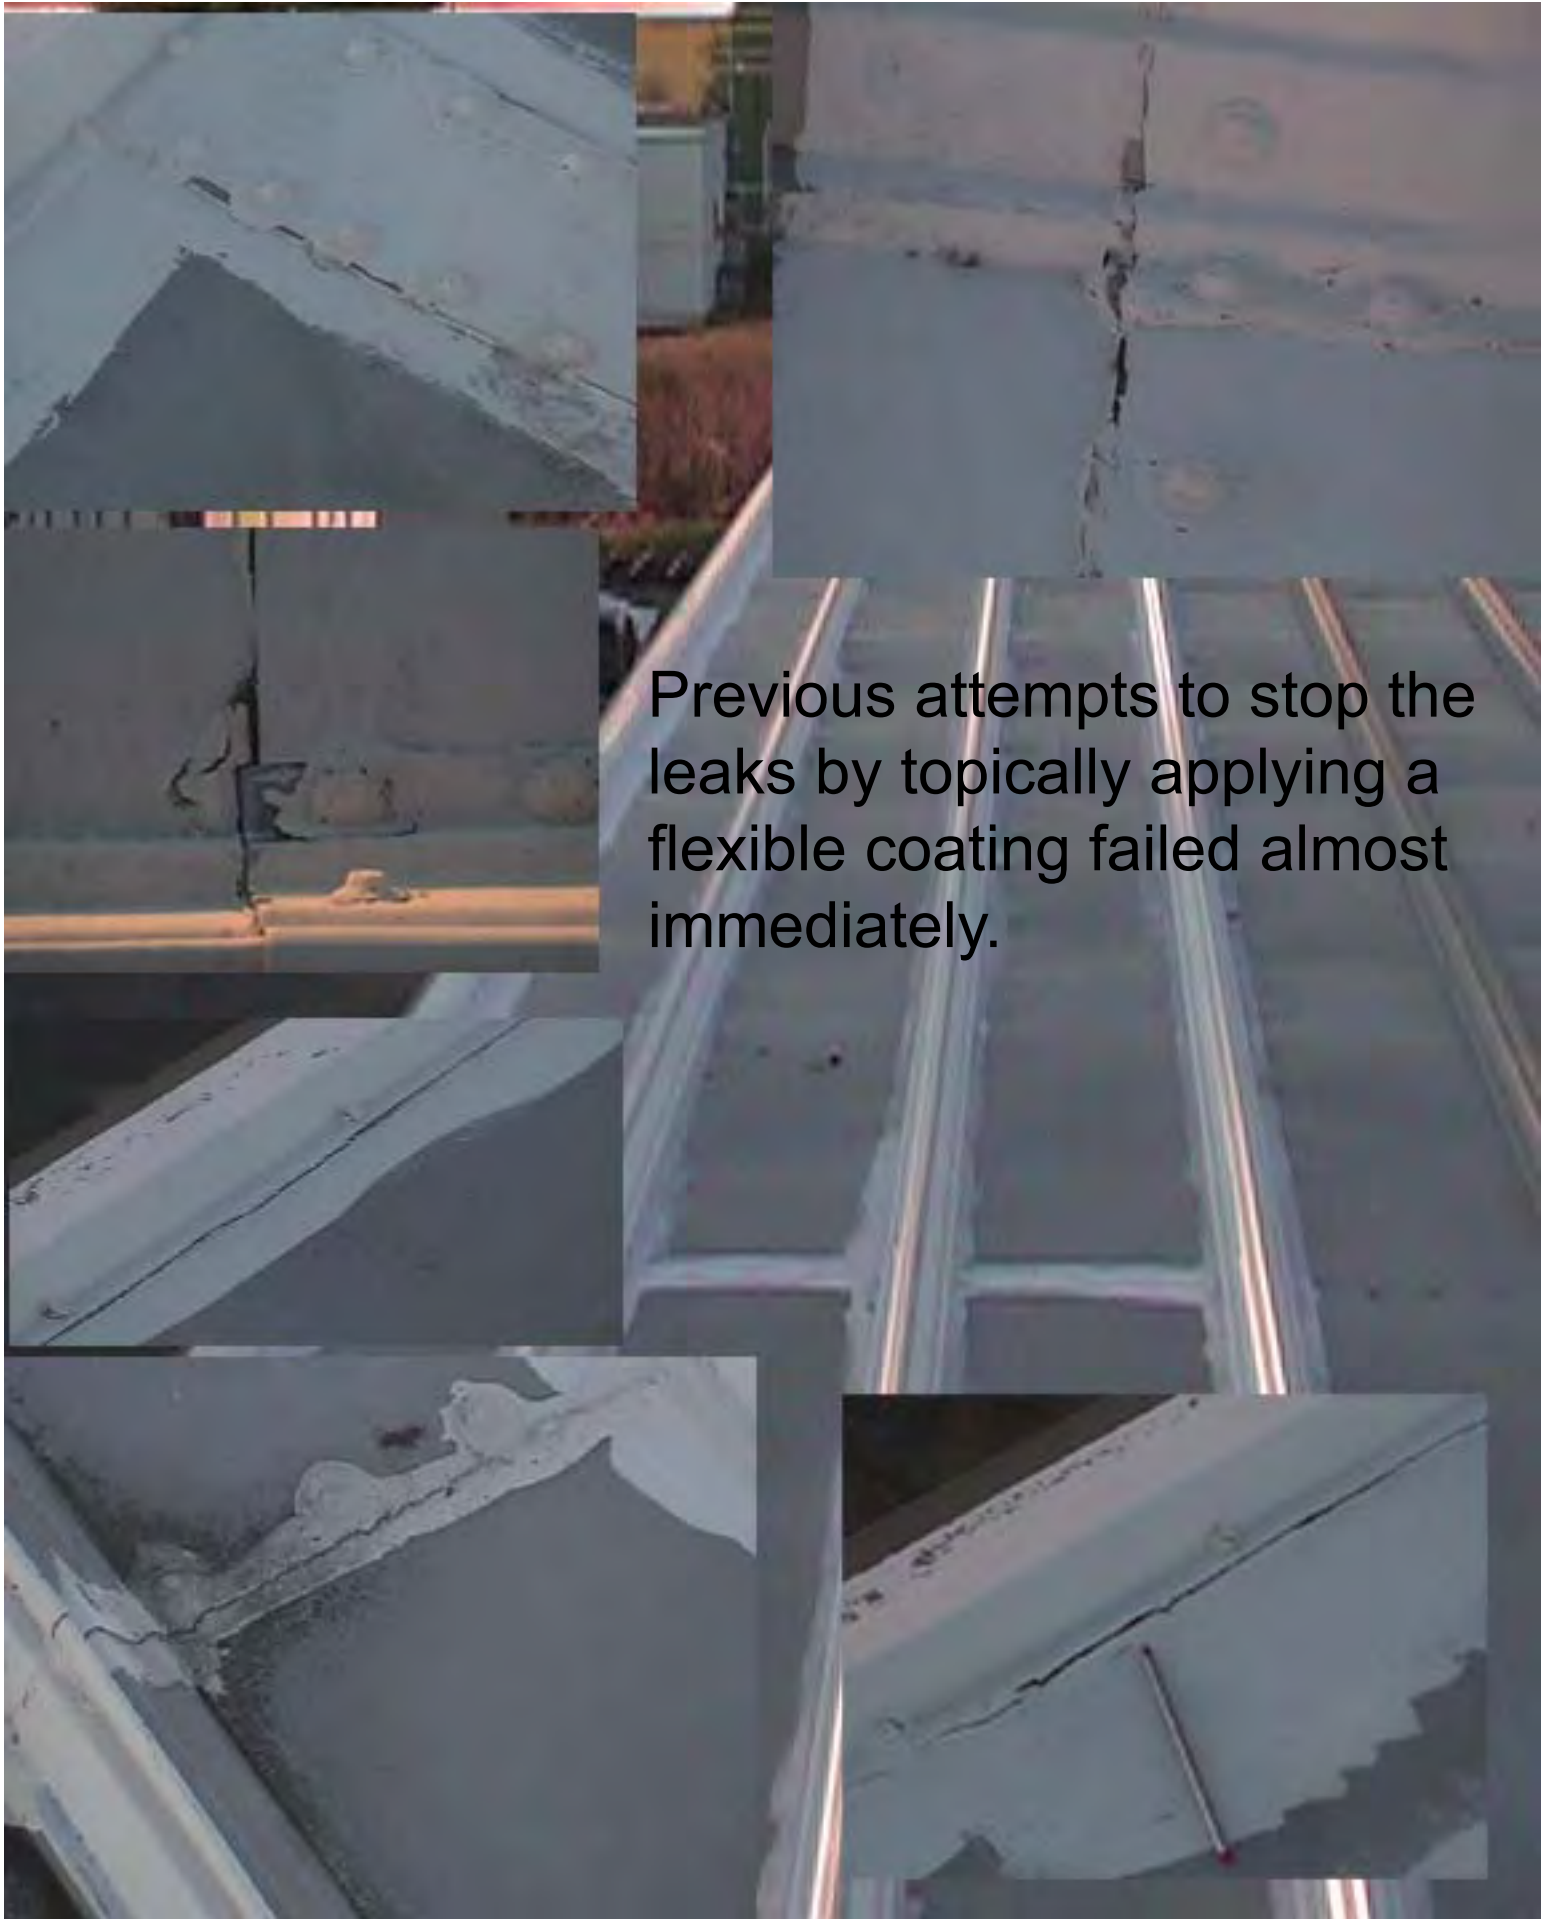
The field of the roof looks good.  
However, water is seeping in  
through loose screws.
