23 year old 320 mil Loose Laid and Ballasted Bluestone Premium Roofing System.

OVER A FAILED BUILT-UP ASPHALT AND GRAVEL ROOF
RETROFIT

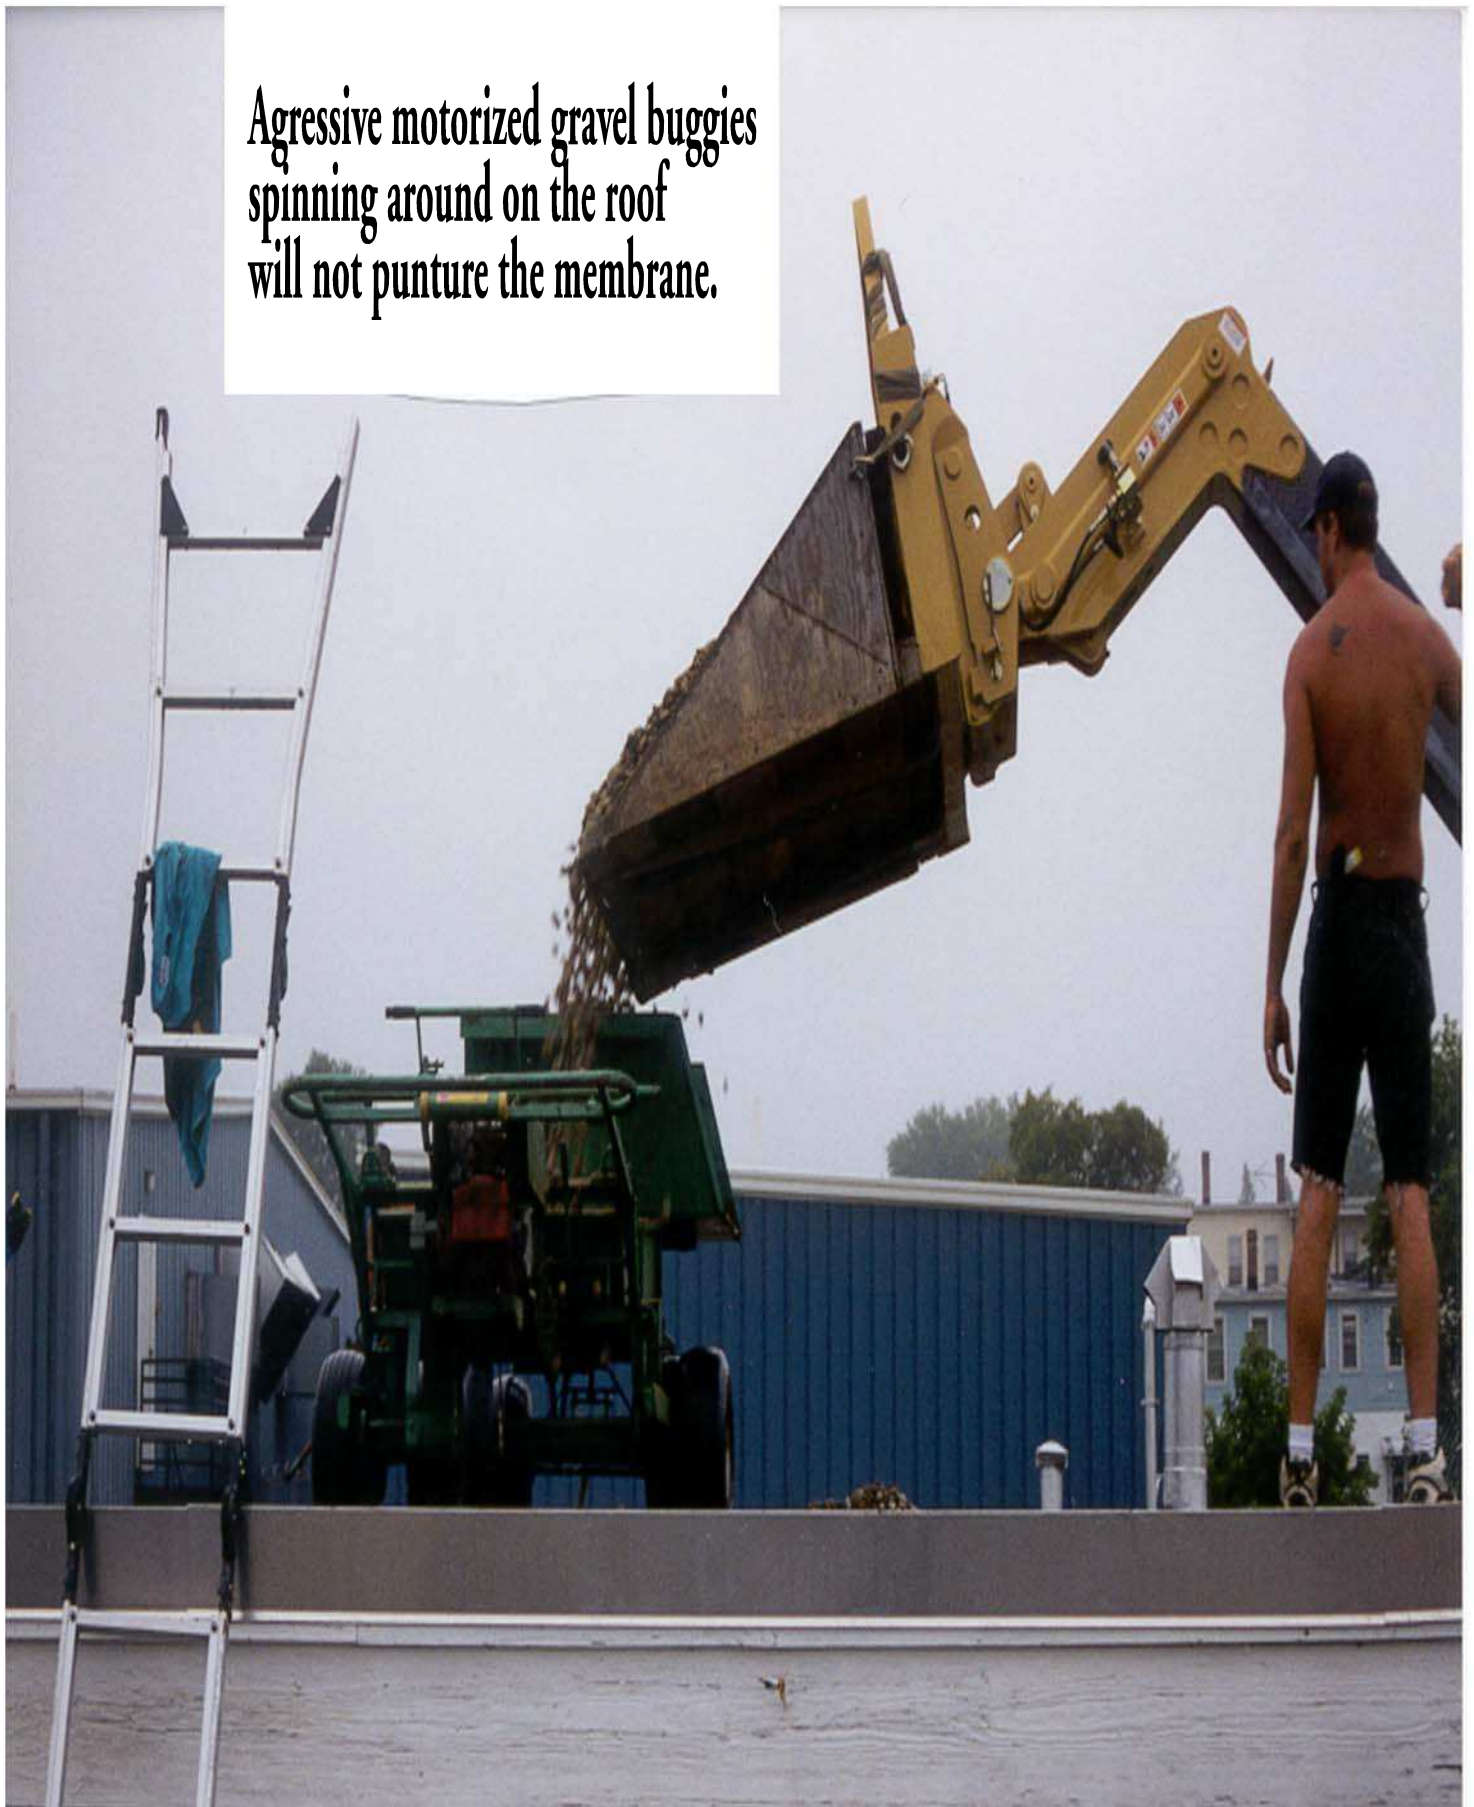
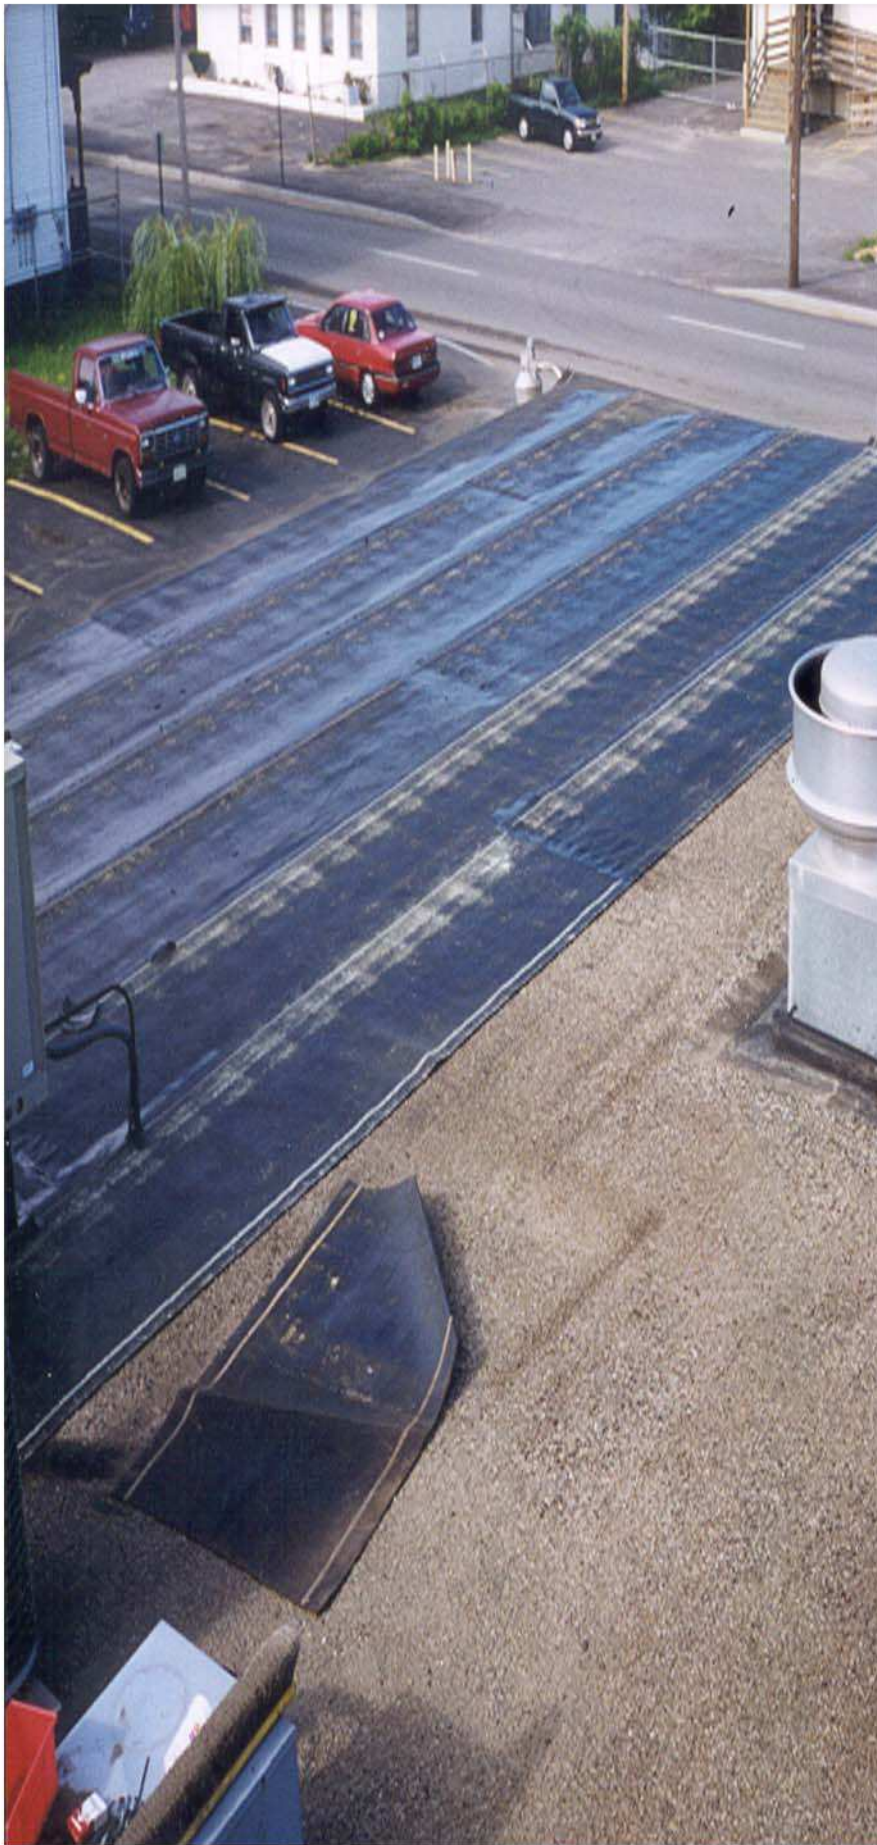
Old roof loaded with broken glass

Agressive motorized gravel buggies
spinning around on the roof
will not punture the membrane.

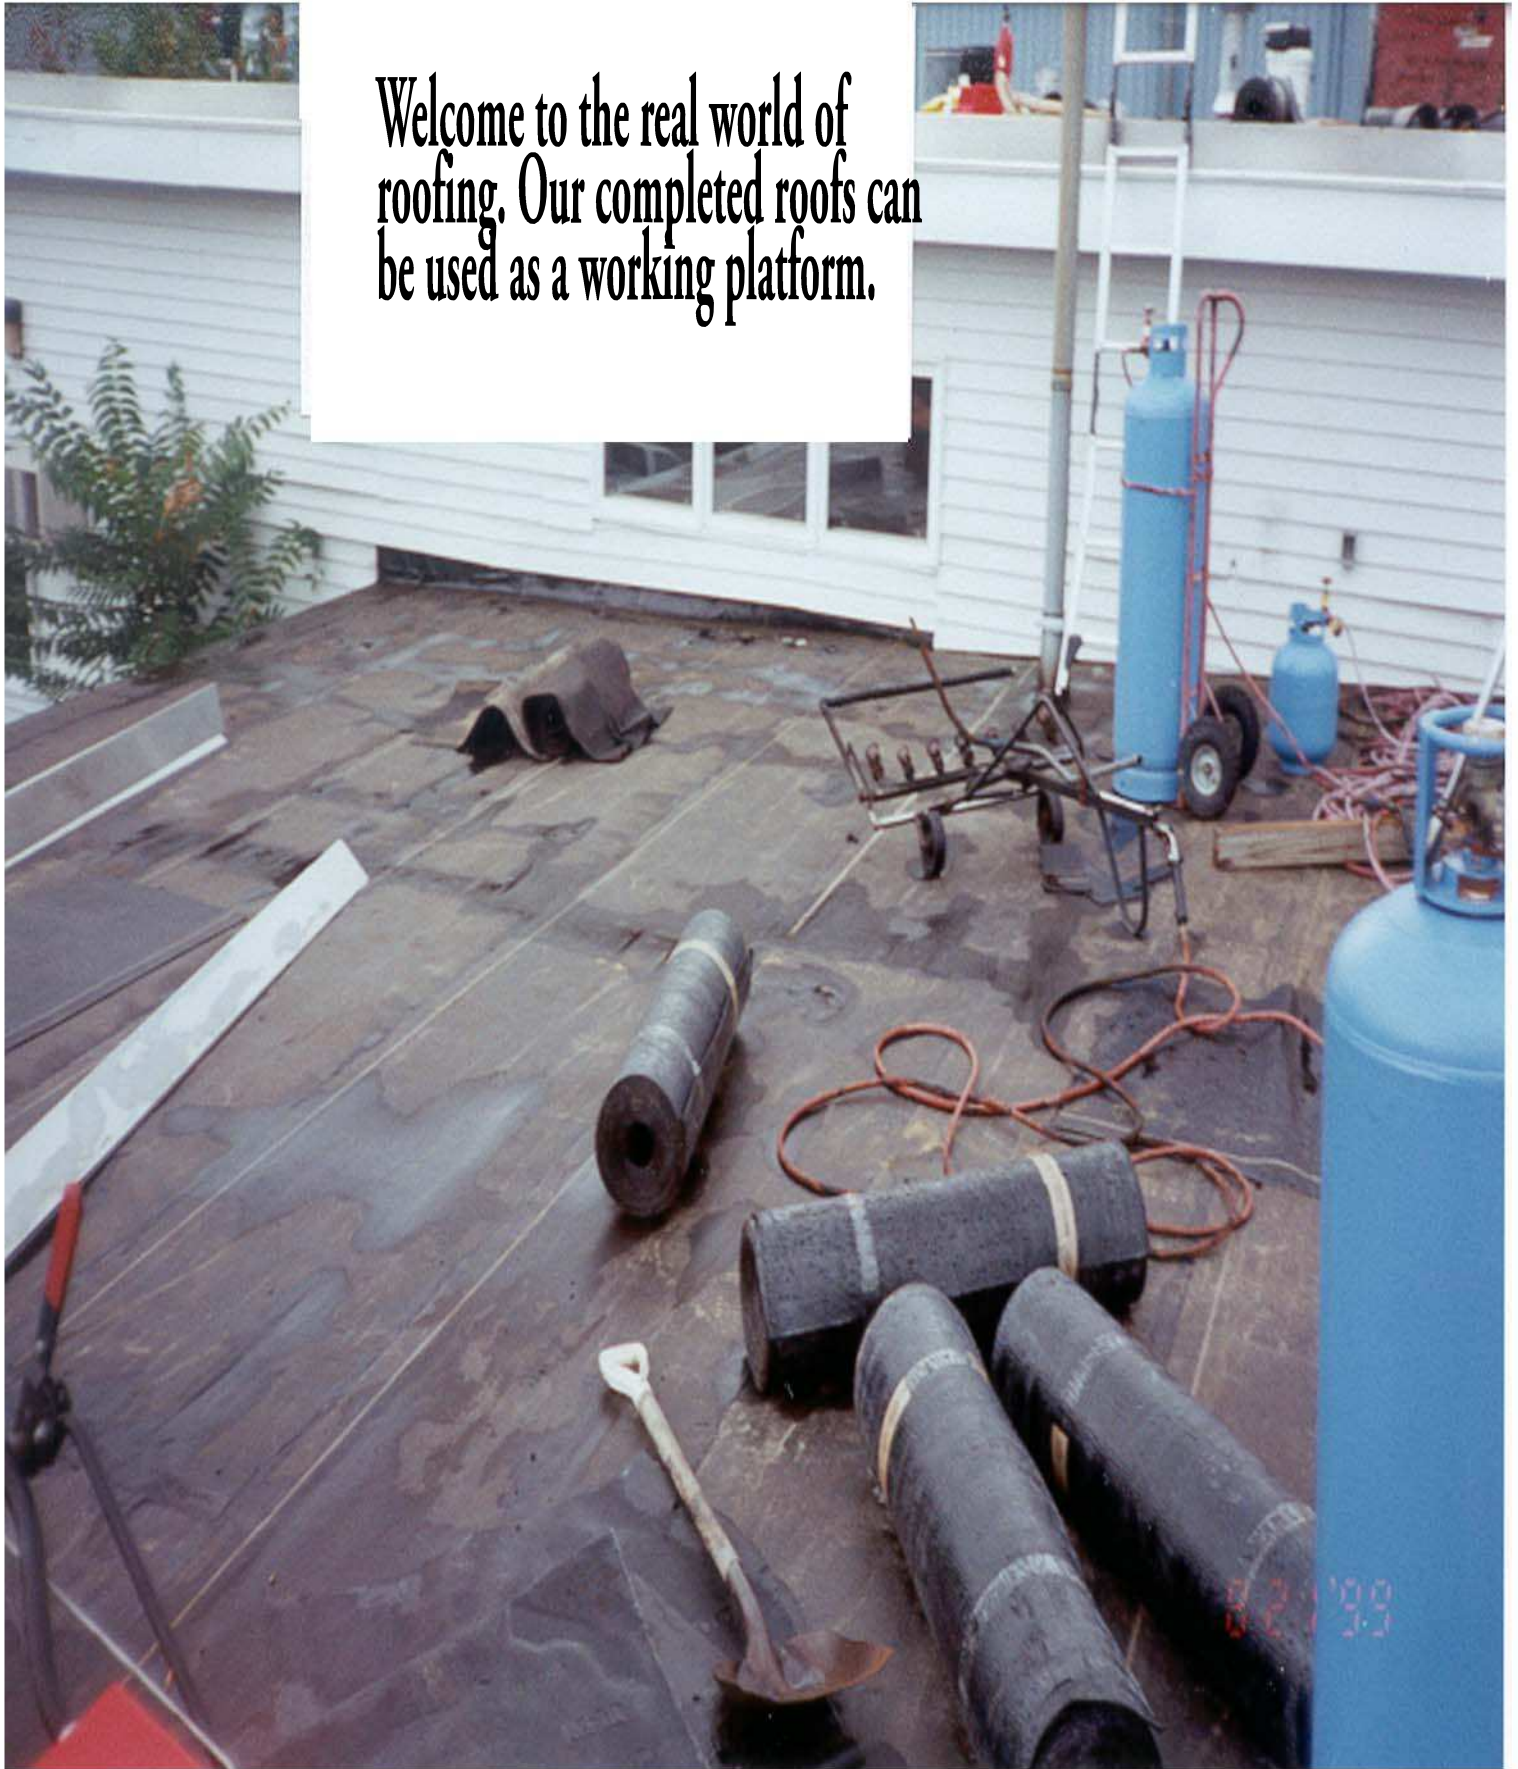
Heavy duty membrane installed directly over a failed asphalt and gravel roof after being swept clean.

Welcome to the real world of roofing. Our completed roofs can be used as a working platform.

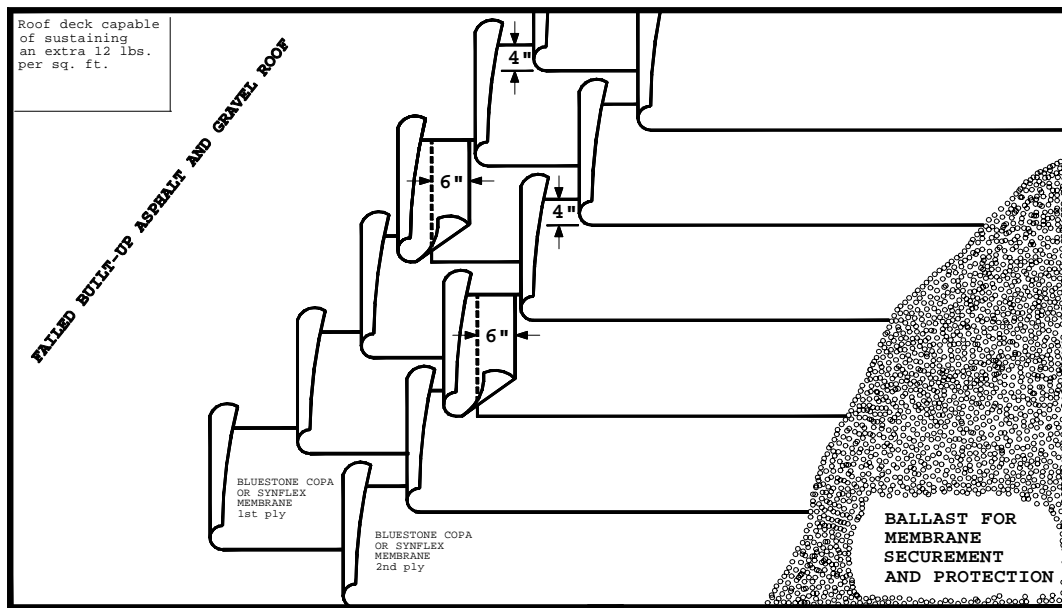
The top ply must have lap
in center of the underlying ply.

Sweep the old roof clean. Puncture the old roof with a 1/2" drill every 4 square feet to allow trapped moisture to escape and prevent future blisters from forming.

Starting at the low point of the roof deck, loose lay the first ply of BLUESTONE membrane over the surface of the failed asphalt and gravel roof and HEAT WELD the seams, making sure to stagger all of the end laps a minimum of 4'. Side laps must be 4" and end laps 6". Fully adhere the second ply to the first ply by HEAT WELDING ONLY. Stagger all of the joints with the previously installed ply a minimum of 4 ft. ADHERING AND SEAMING THE BLUESTONE MEMBRANES WITH GLUES OR HOT ASPHALT WILL AUTOMATICALLY VOID THE WARRANTY.

The new roof will be ballasted with 2 to 3 inch stone at a rate of 10 lbs. per square foot.

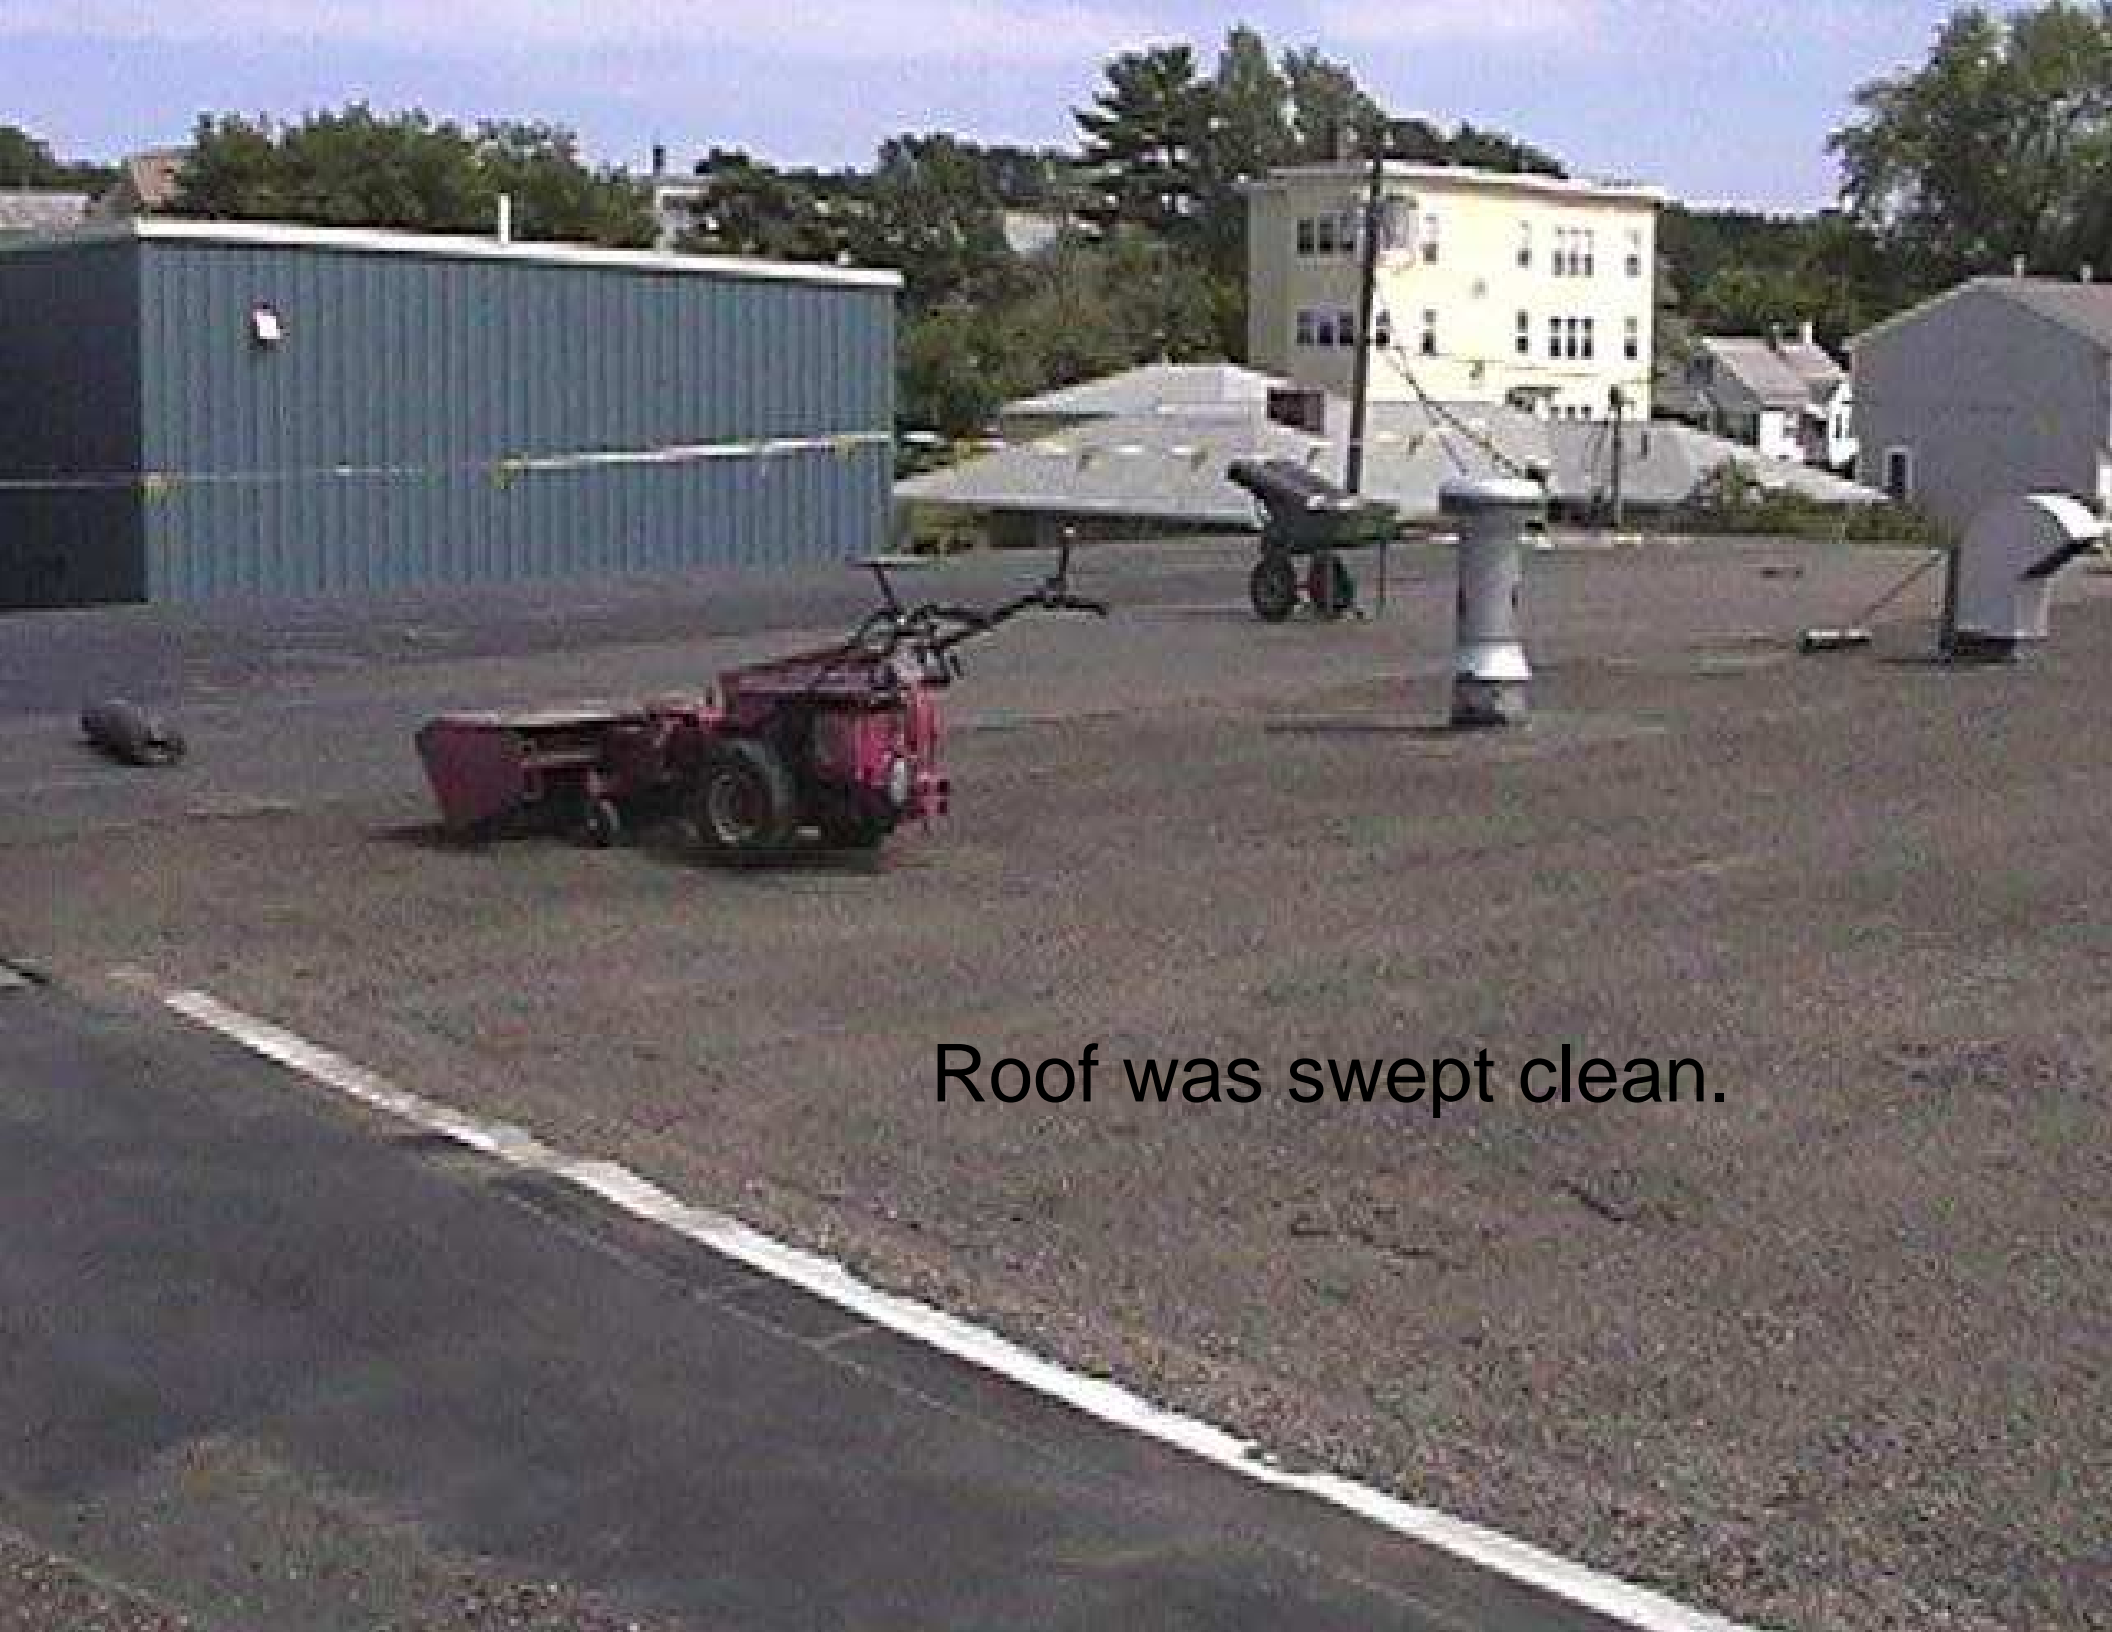
Roof was swept clean.

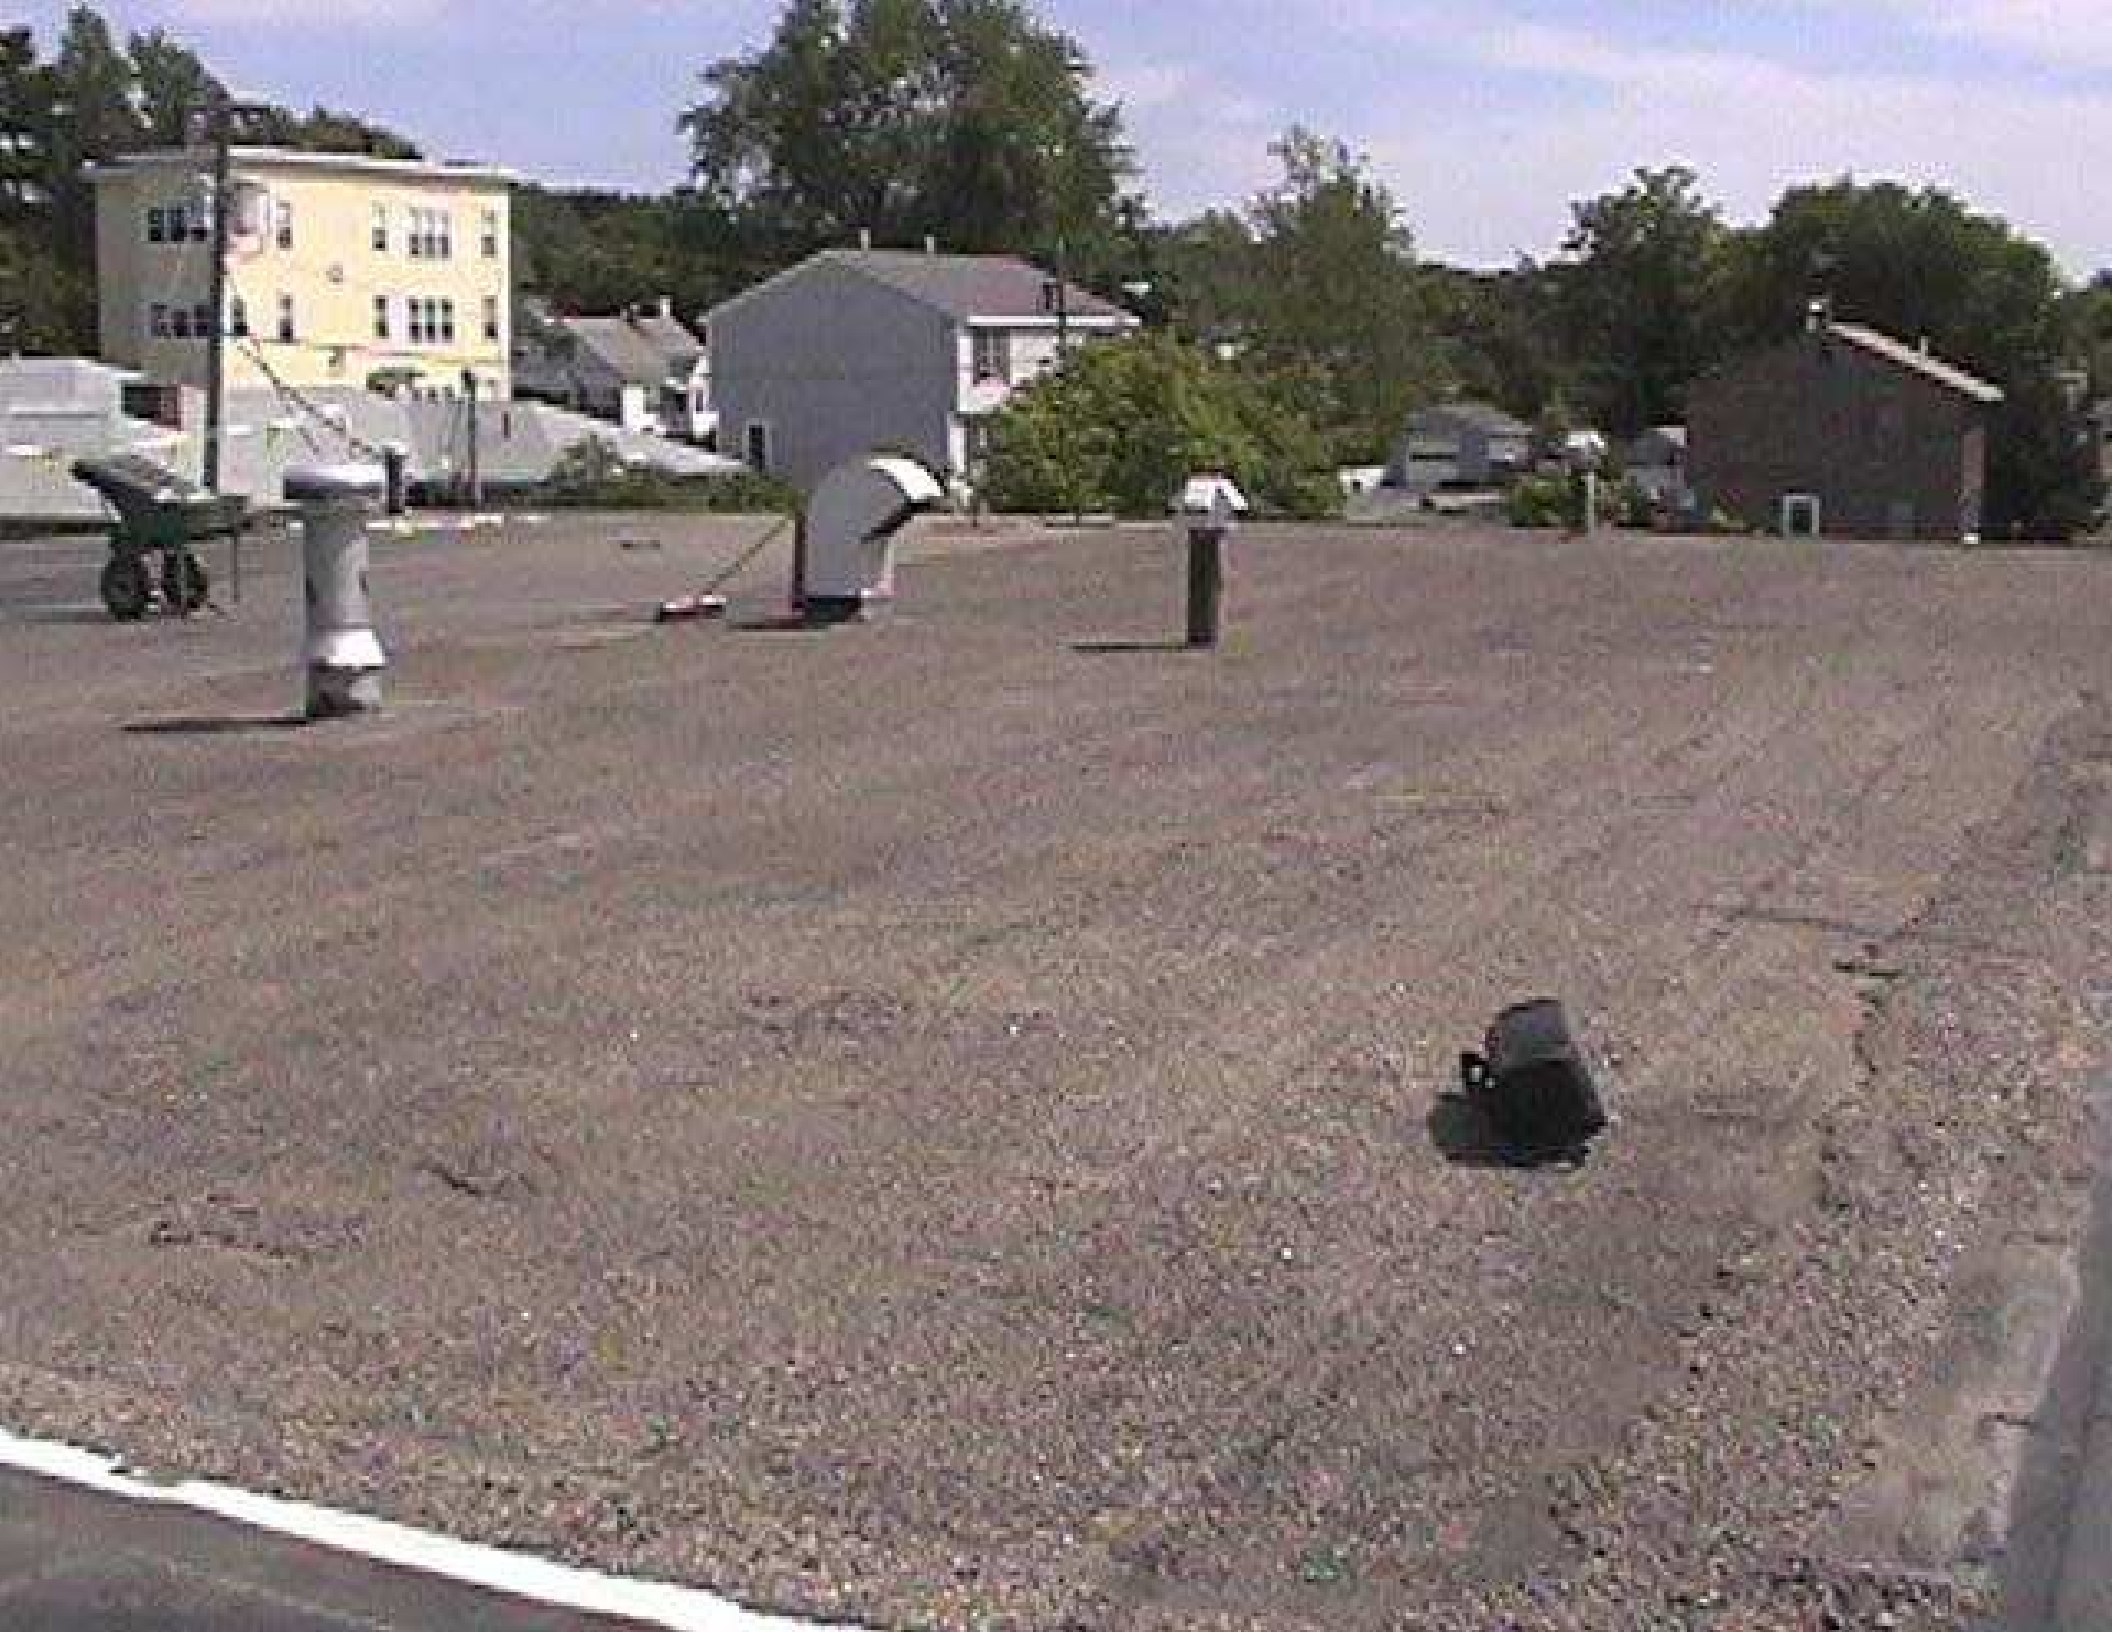
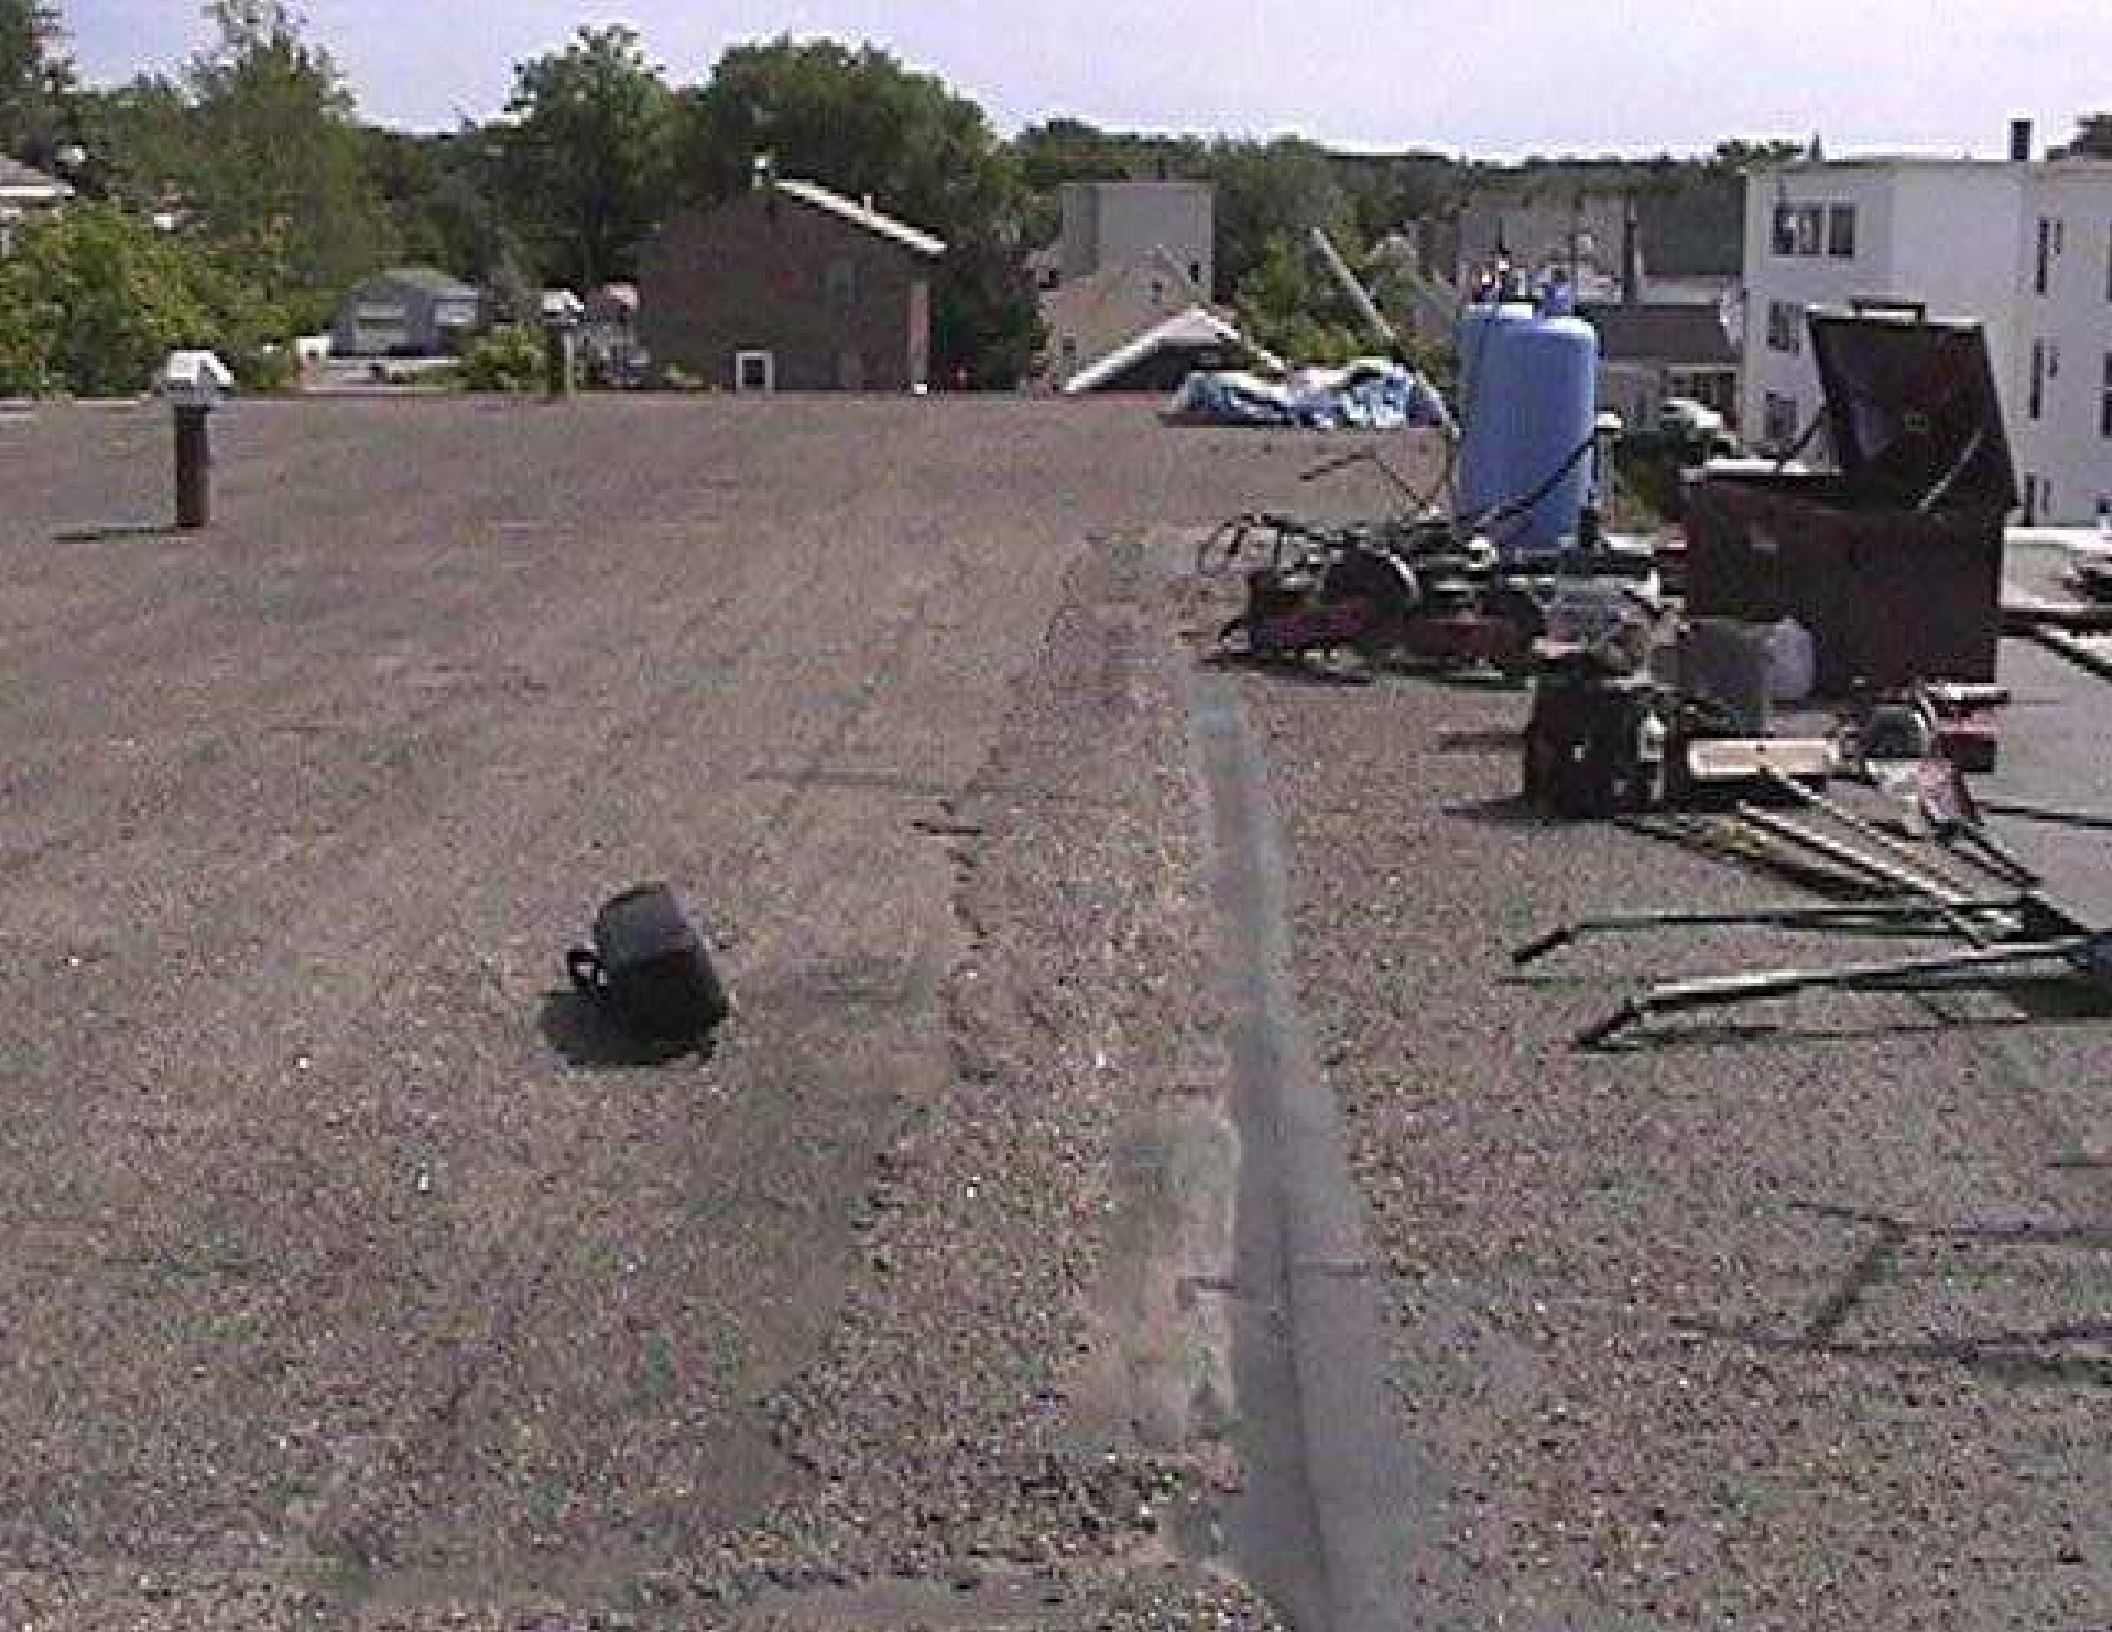
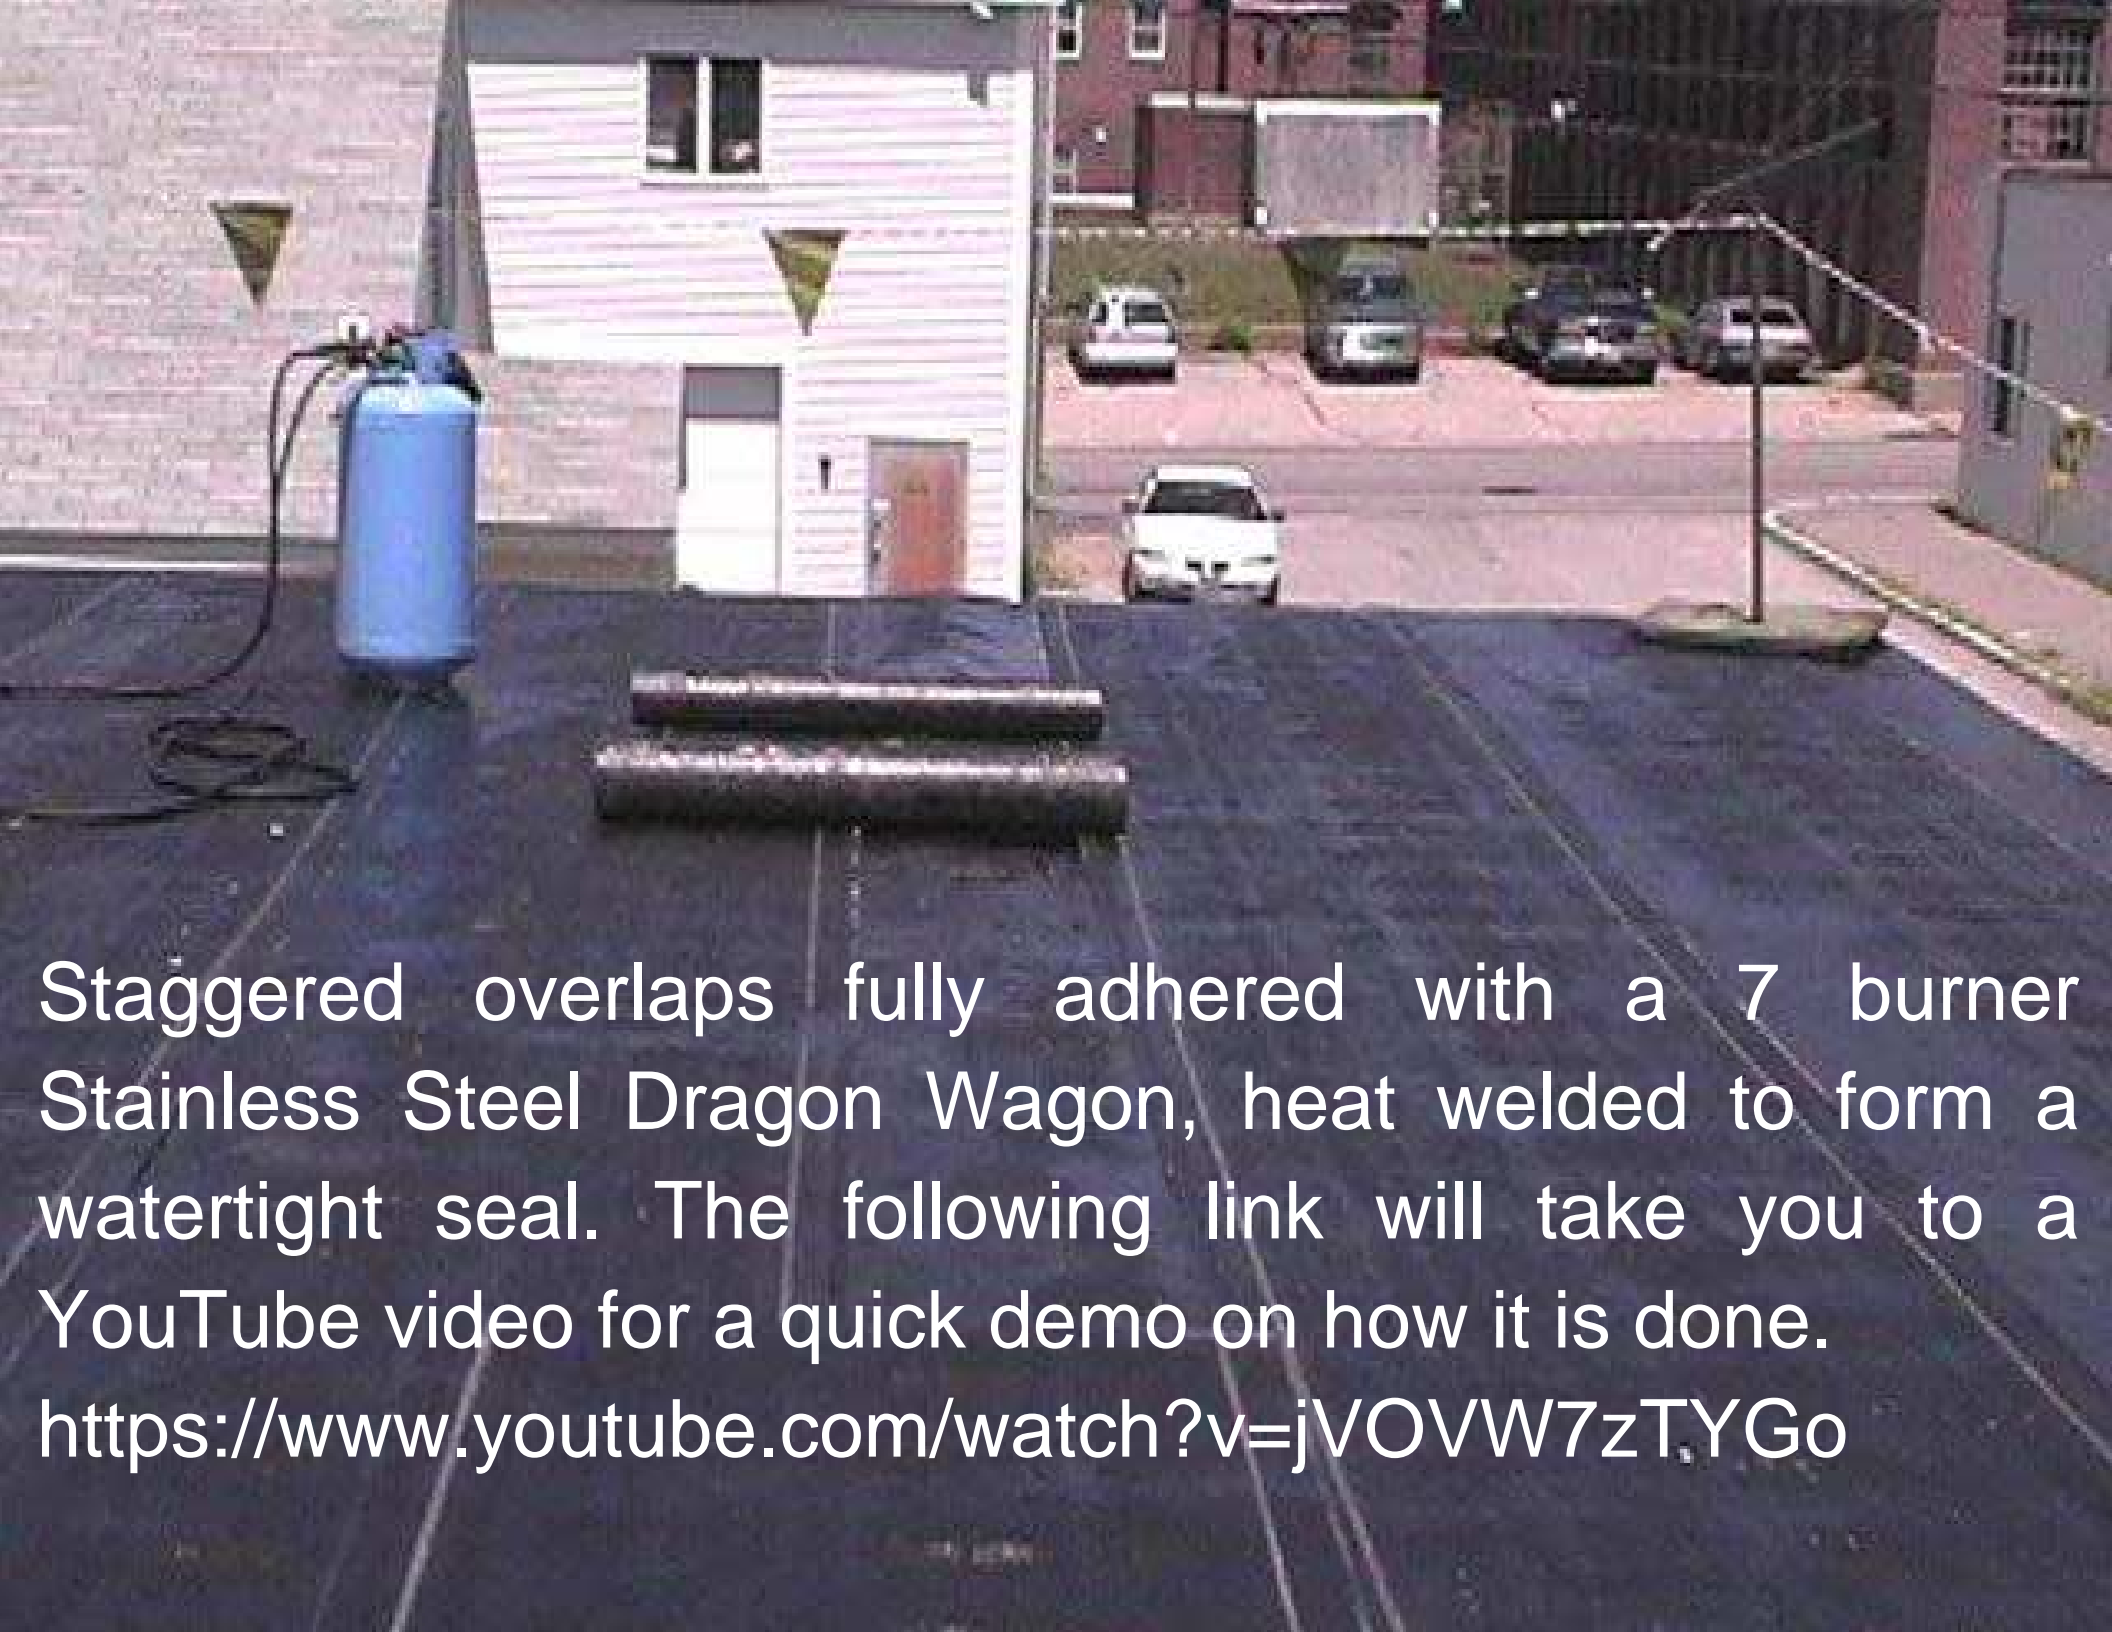
Staggered overlaps fully adhered with a 7 burner Stainless Steel Dragon Wagon, heat welded to form a watertight seal. The following link will take you to a YouTube video for a quick demo on how it is done.
