23 year old 320 mil Loose Laid and Ballasted Bluestone Premium Roofing System.

OVER A FAILED BUILT-UP ASPHALT AND GRAVEL ROOF
RETROFIT

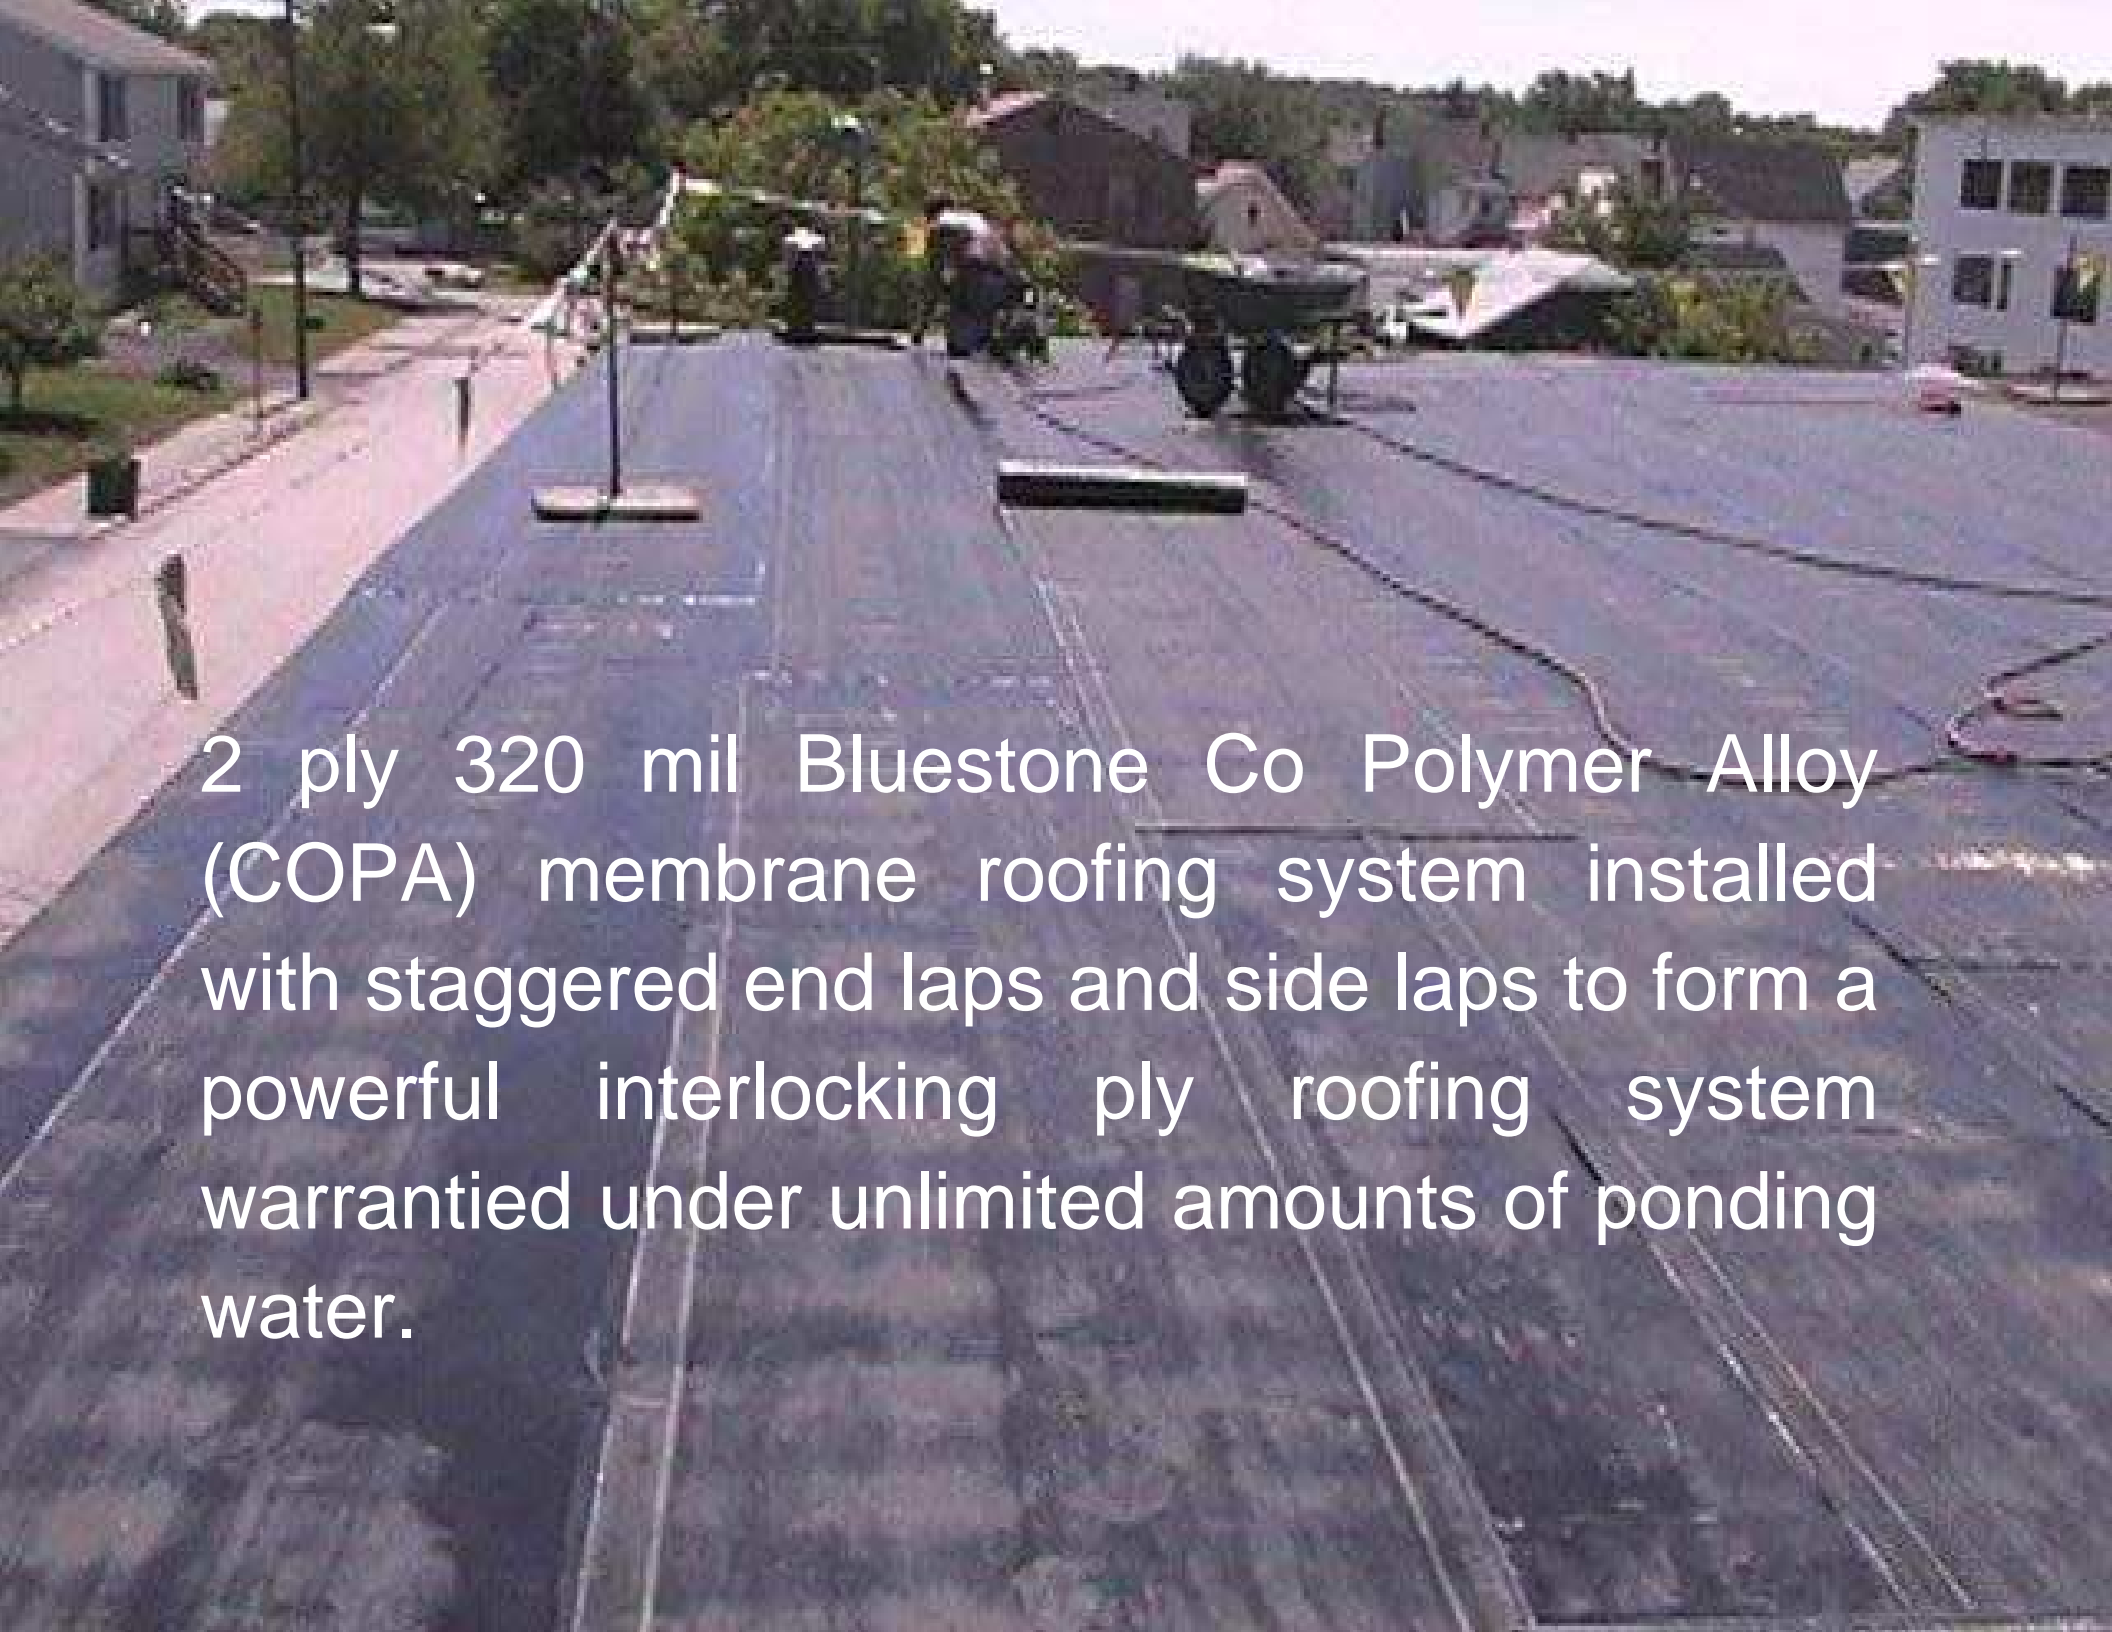
2 ply 320 mil Bluestone Co Polymer Alloy (COPA) membrane roofing system installed with staggered end laps and side laps to form a powerful interlocking ply roofing system warrantied under unlimited amounts of ponding water.

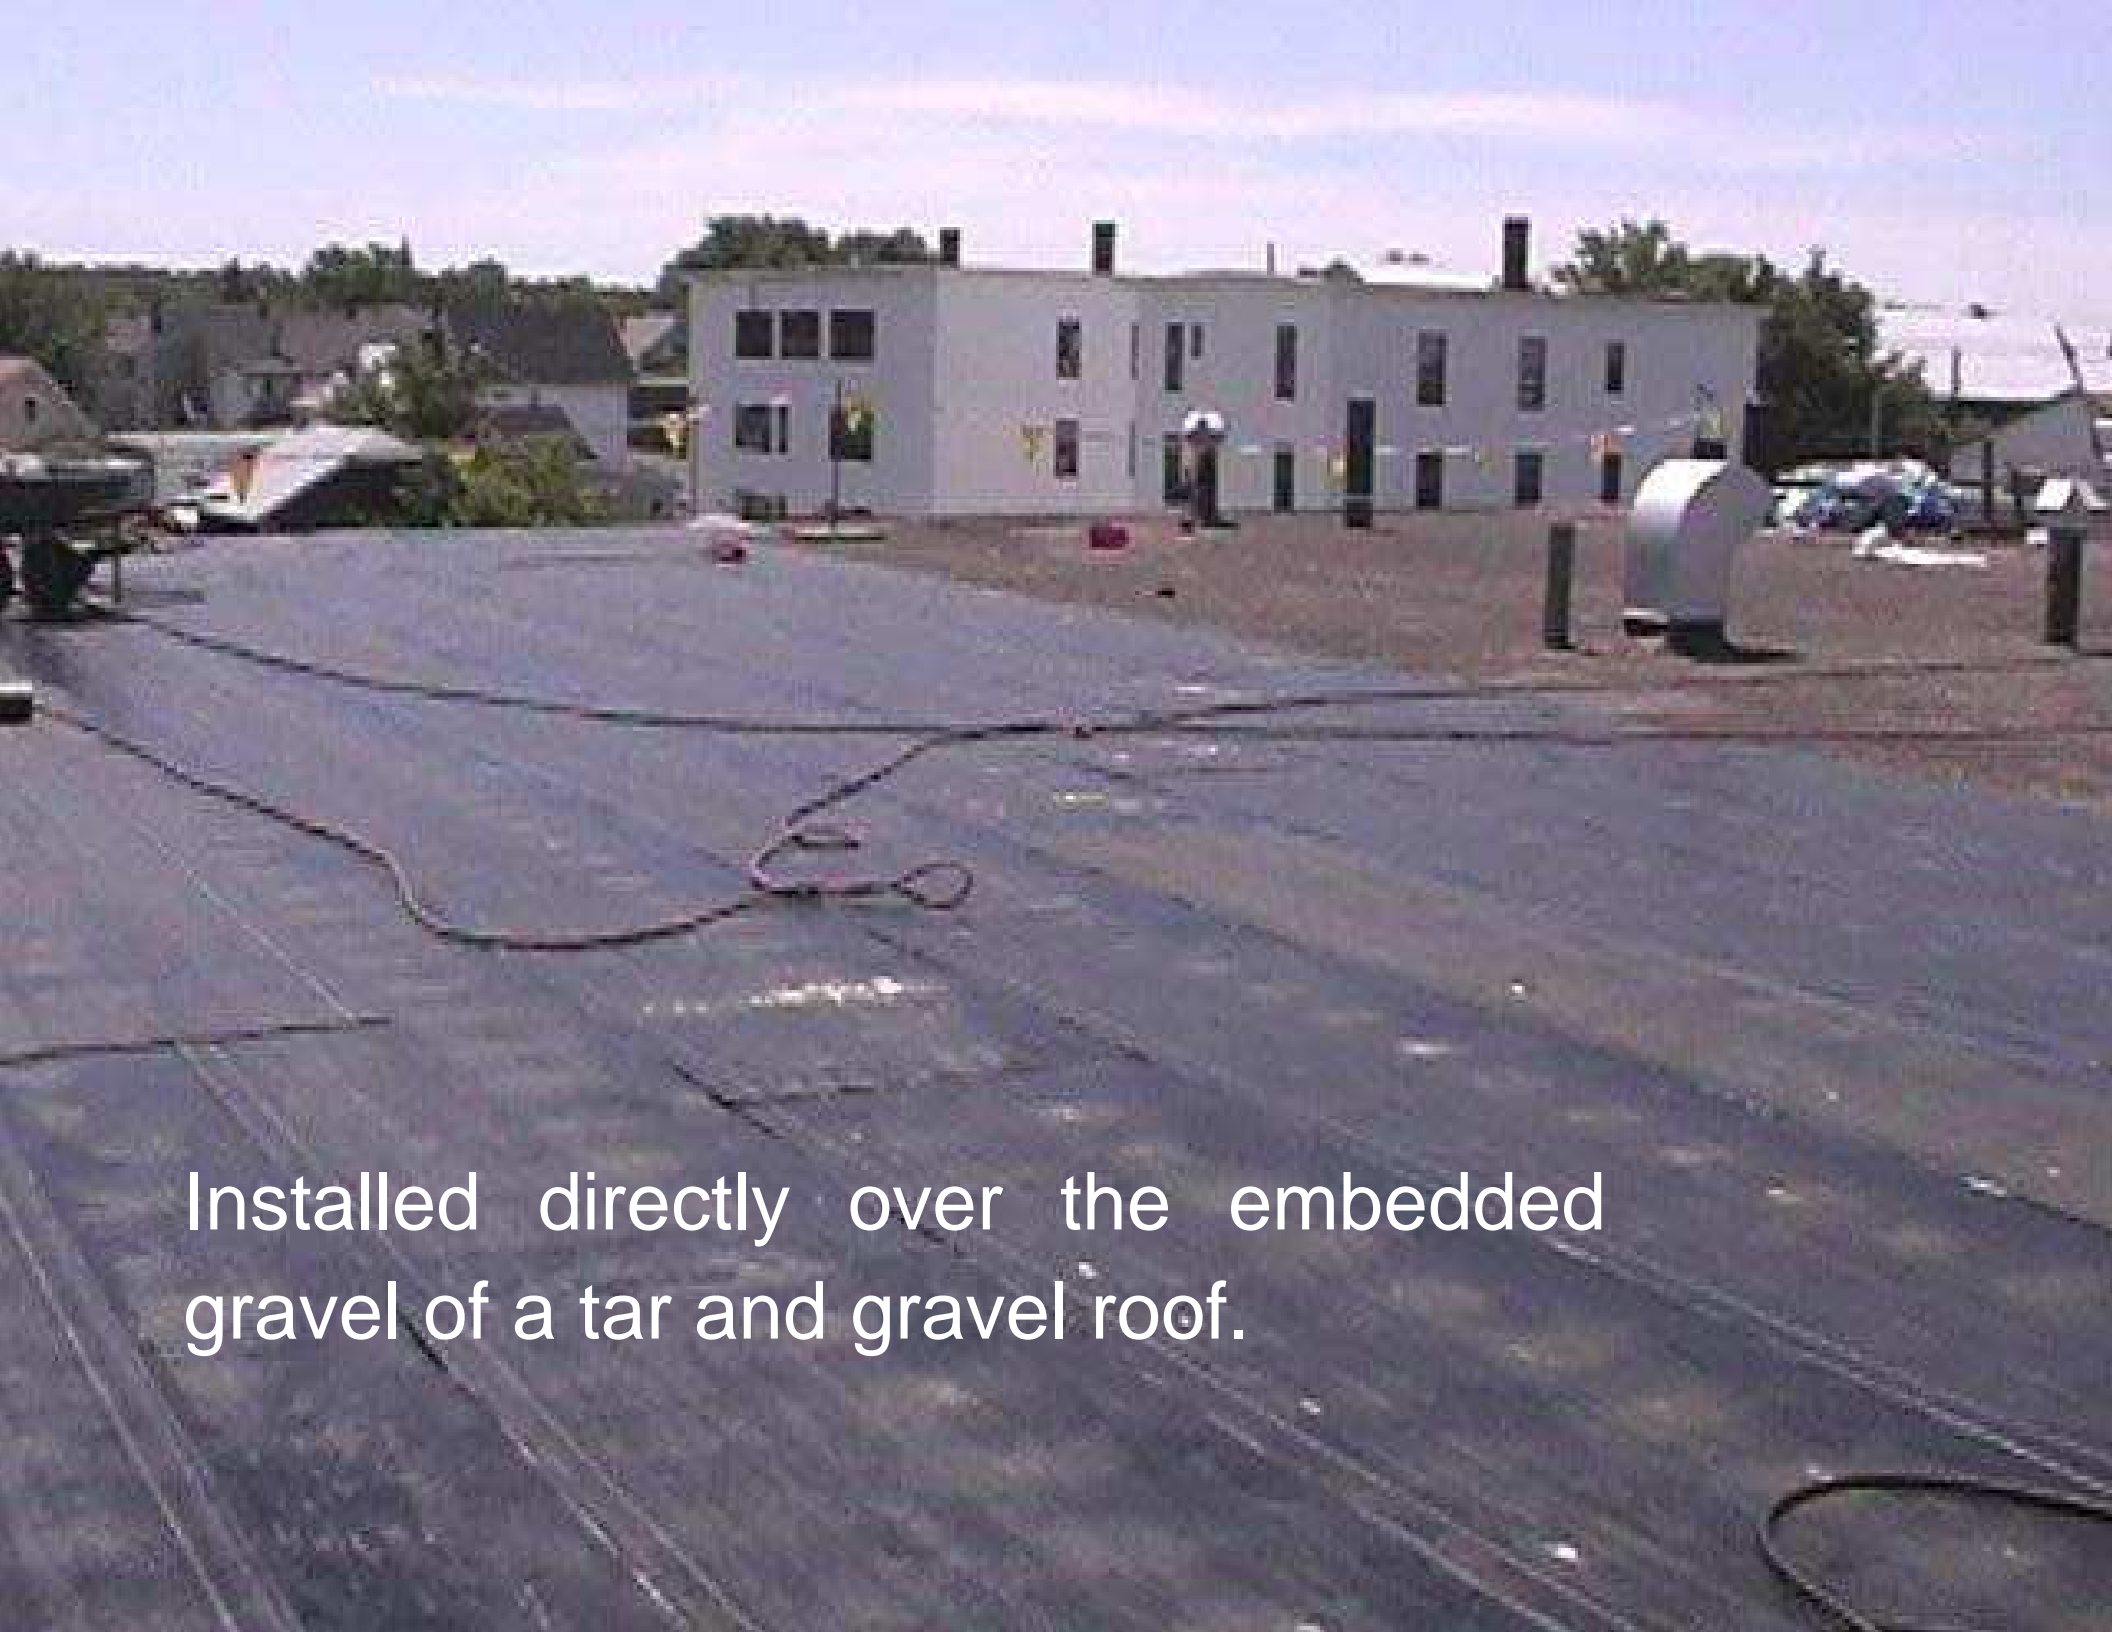
Installed directly over the embedded gravel of a tar and gravel roof.

Drainage side .050 aluminum angle iron was installed to hold the stones on the roof. They were heat welded to a strip of Bluestone Synflex membrane 1" apart to allow for proper drainage.

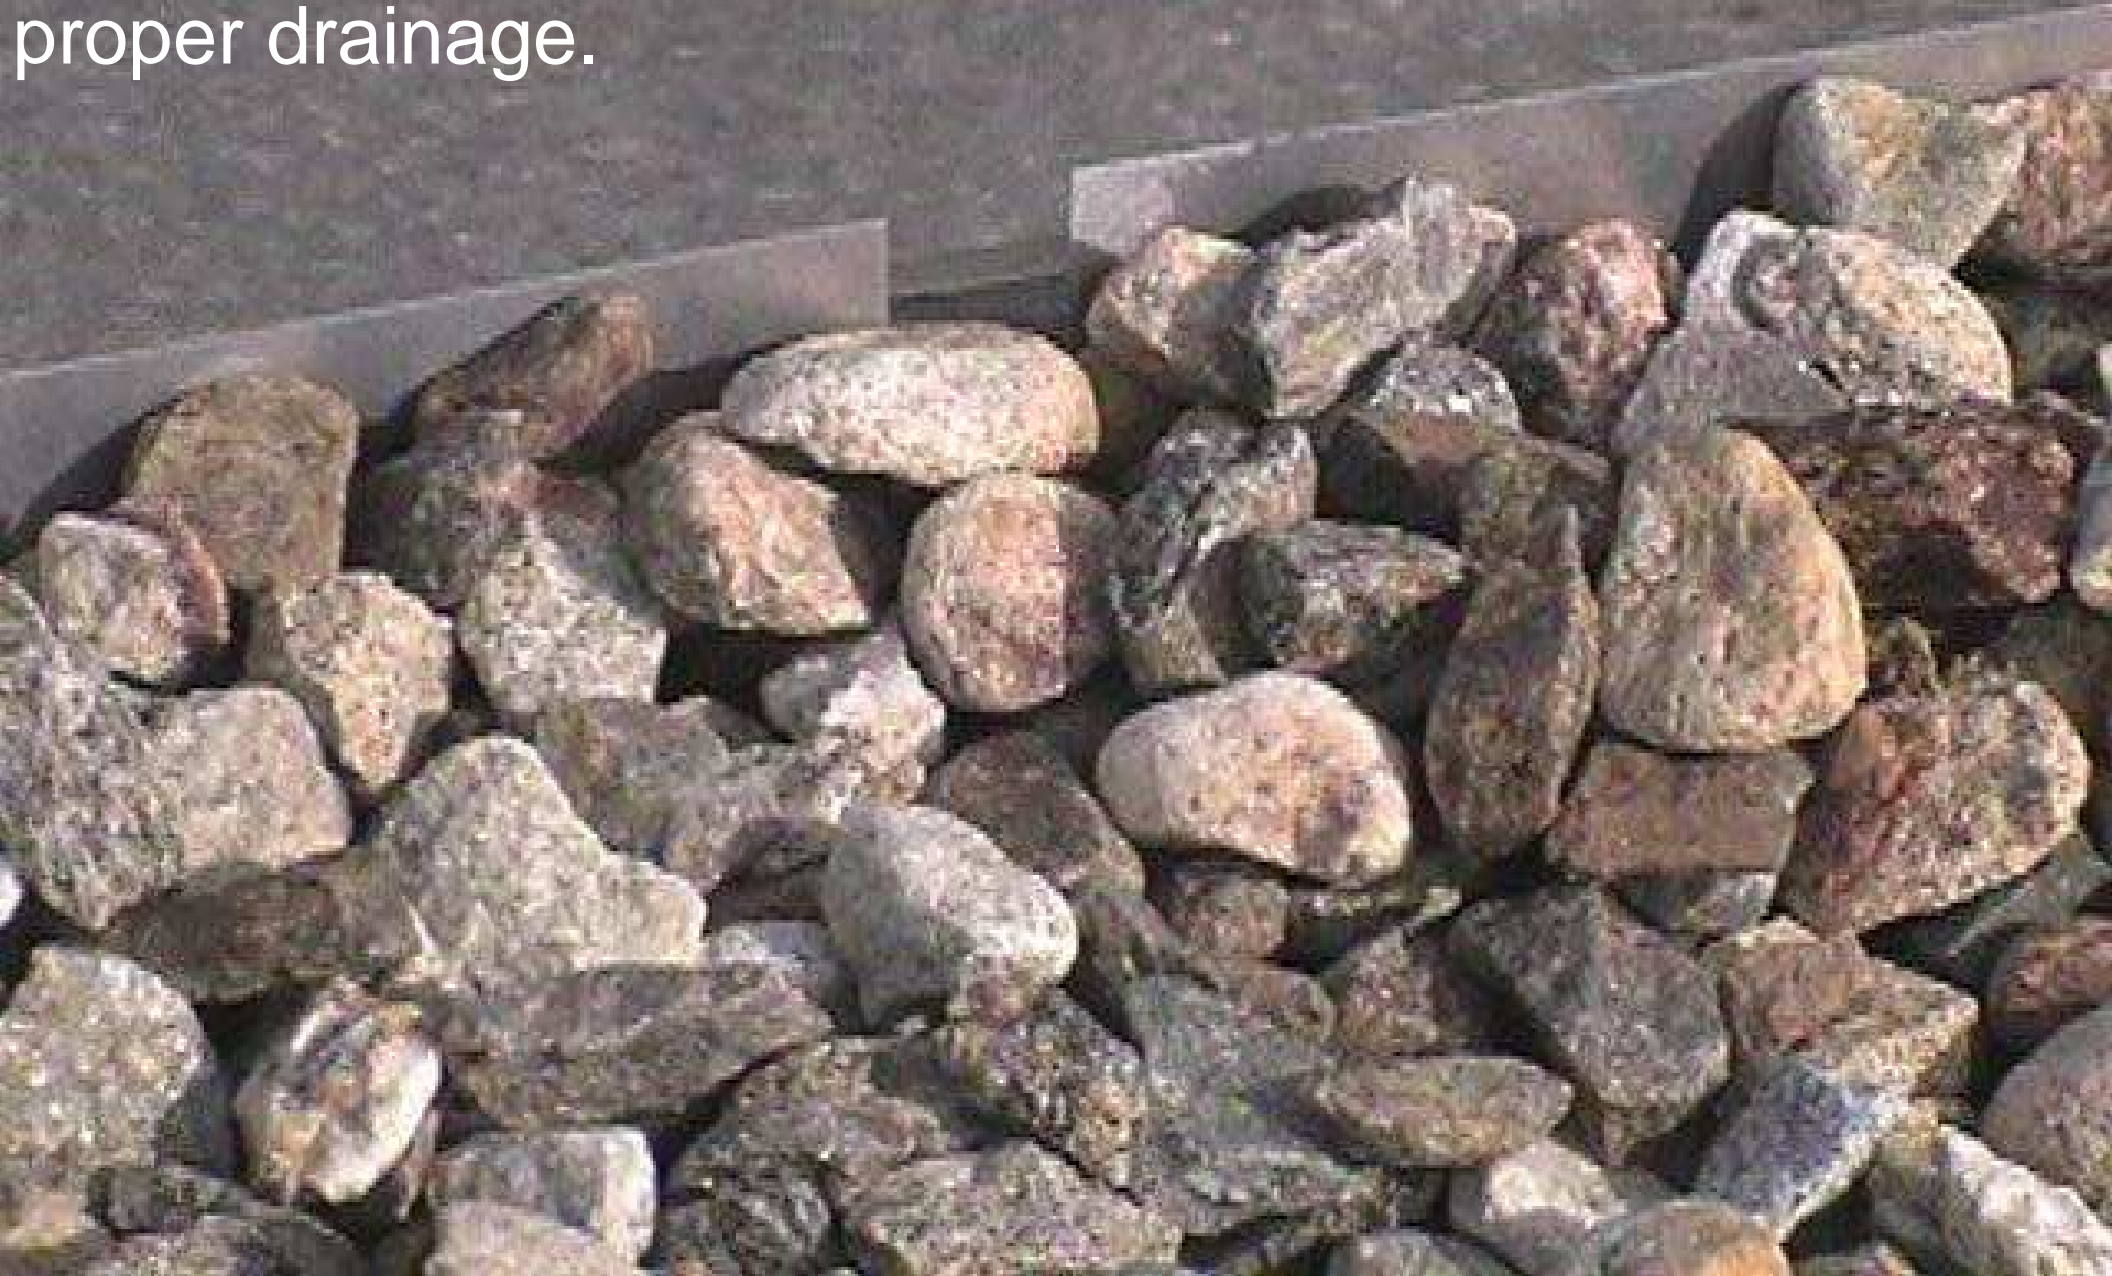
6 inch kick
with .050 heavy
duty aluminum
drip edge on the
drainage side of
the building
prevents water
damage to the
outside walls.

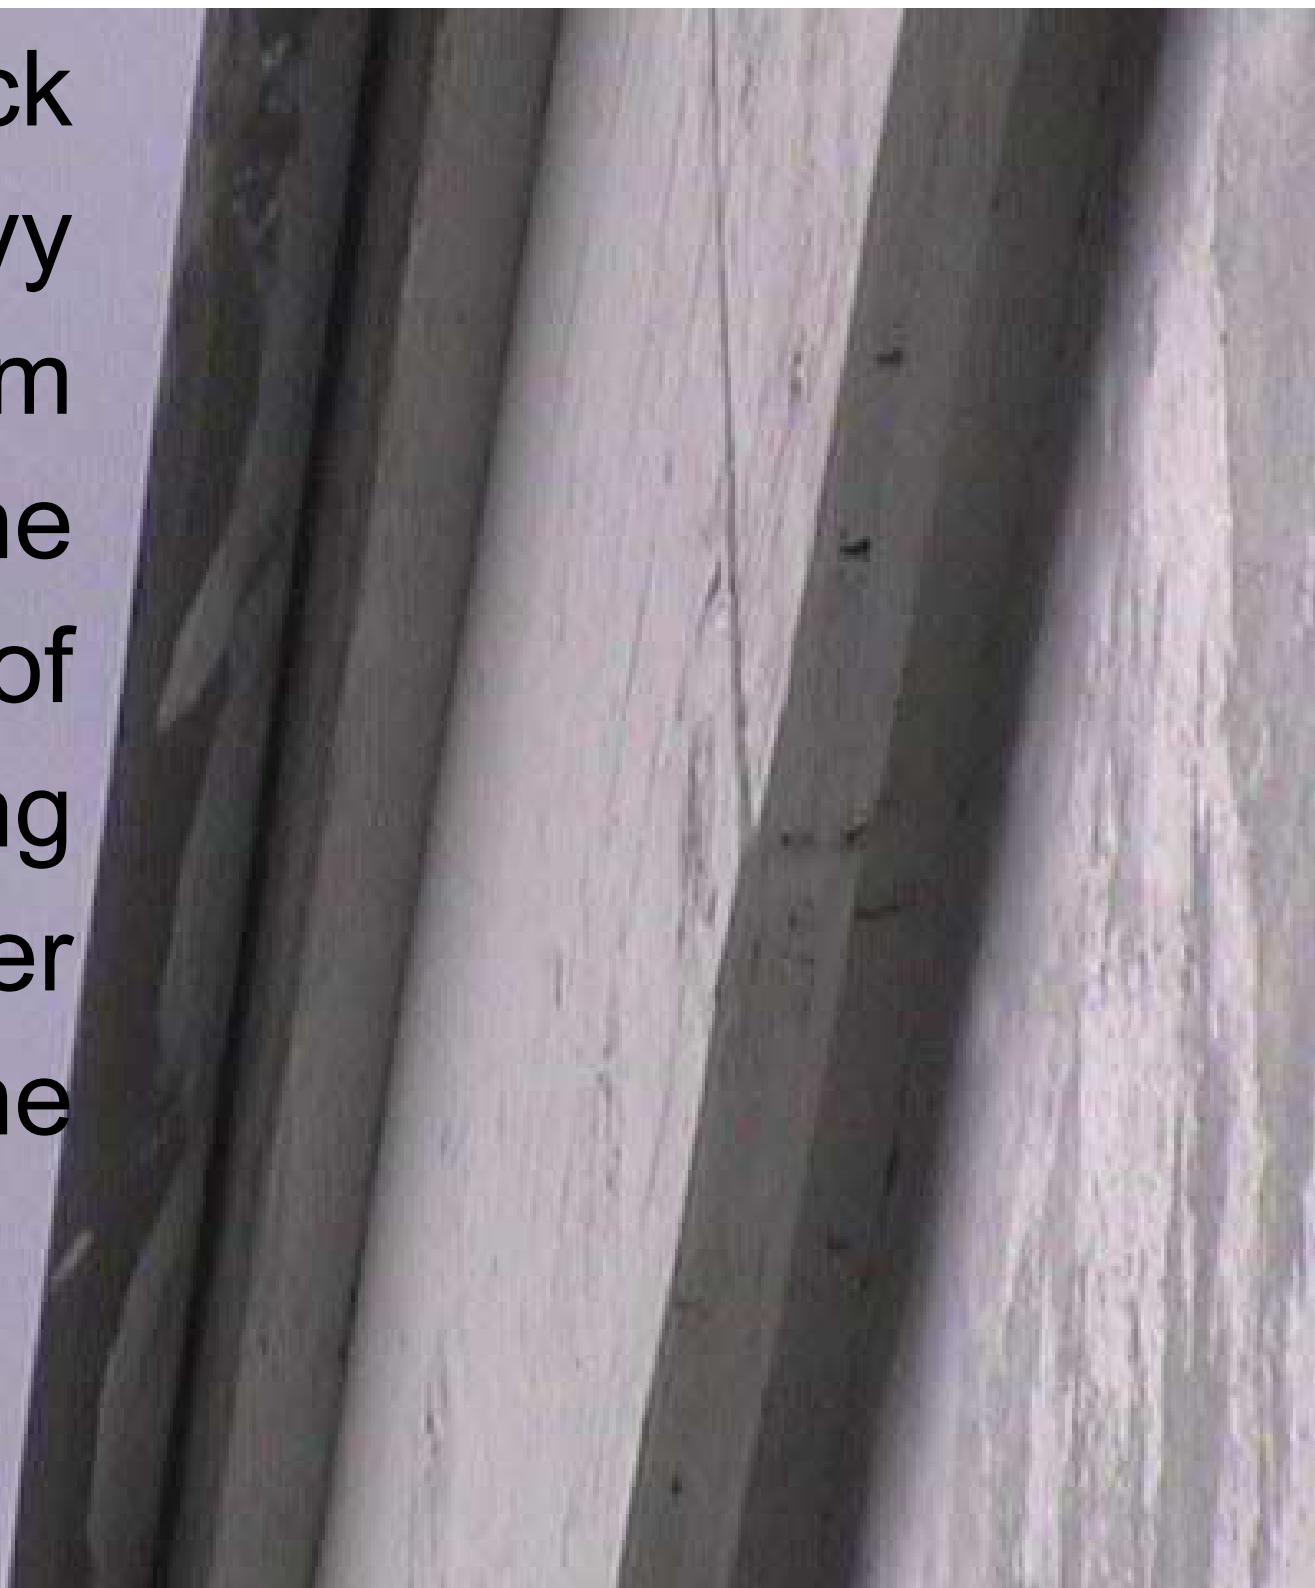
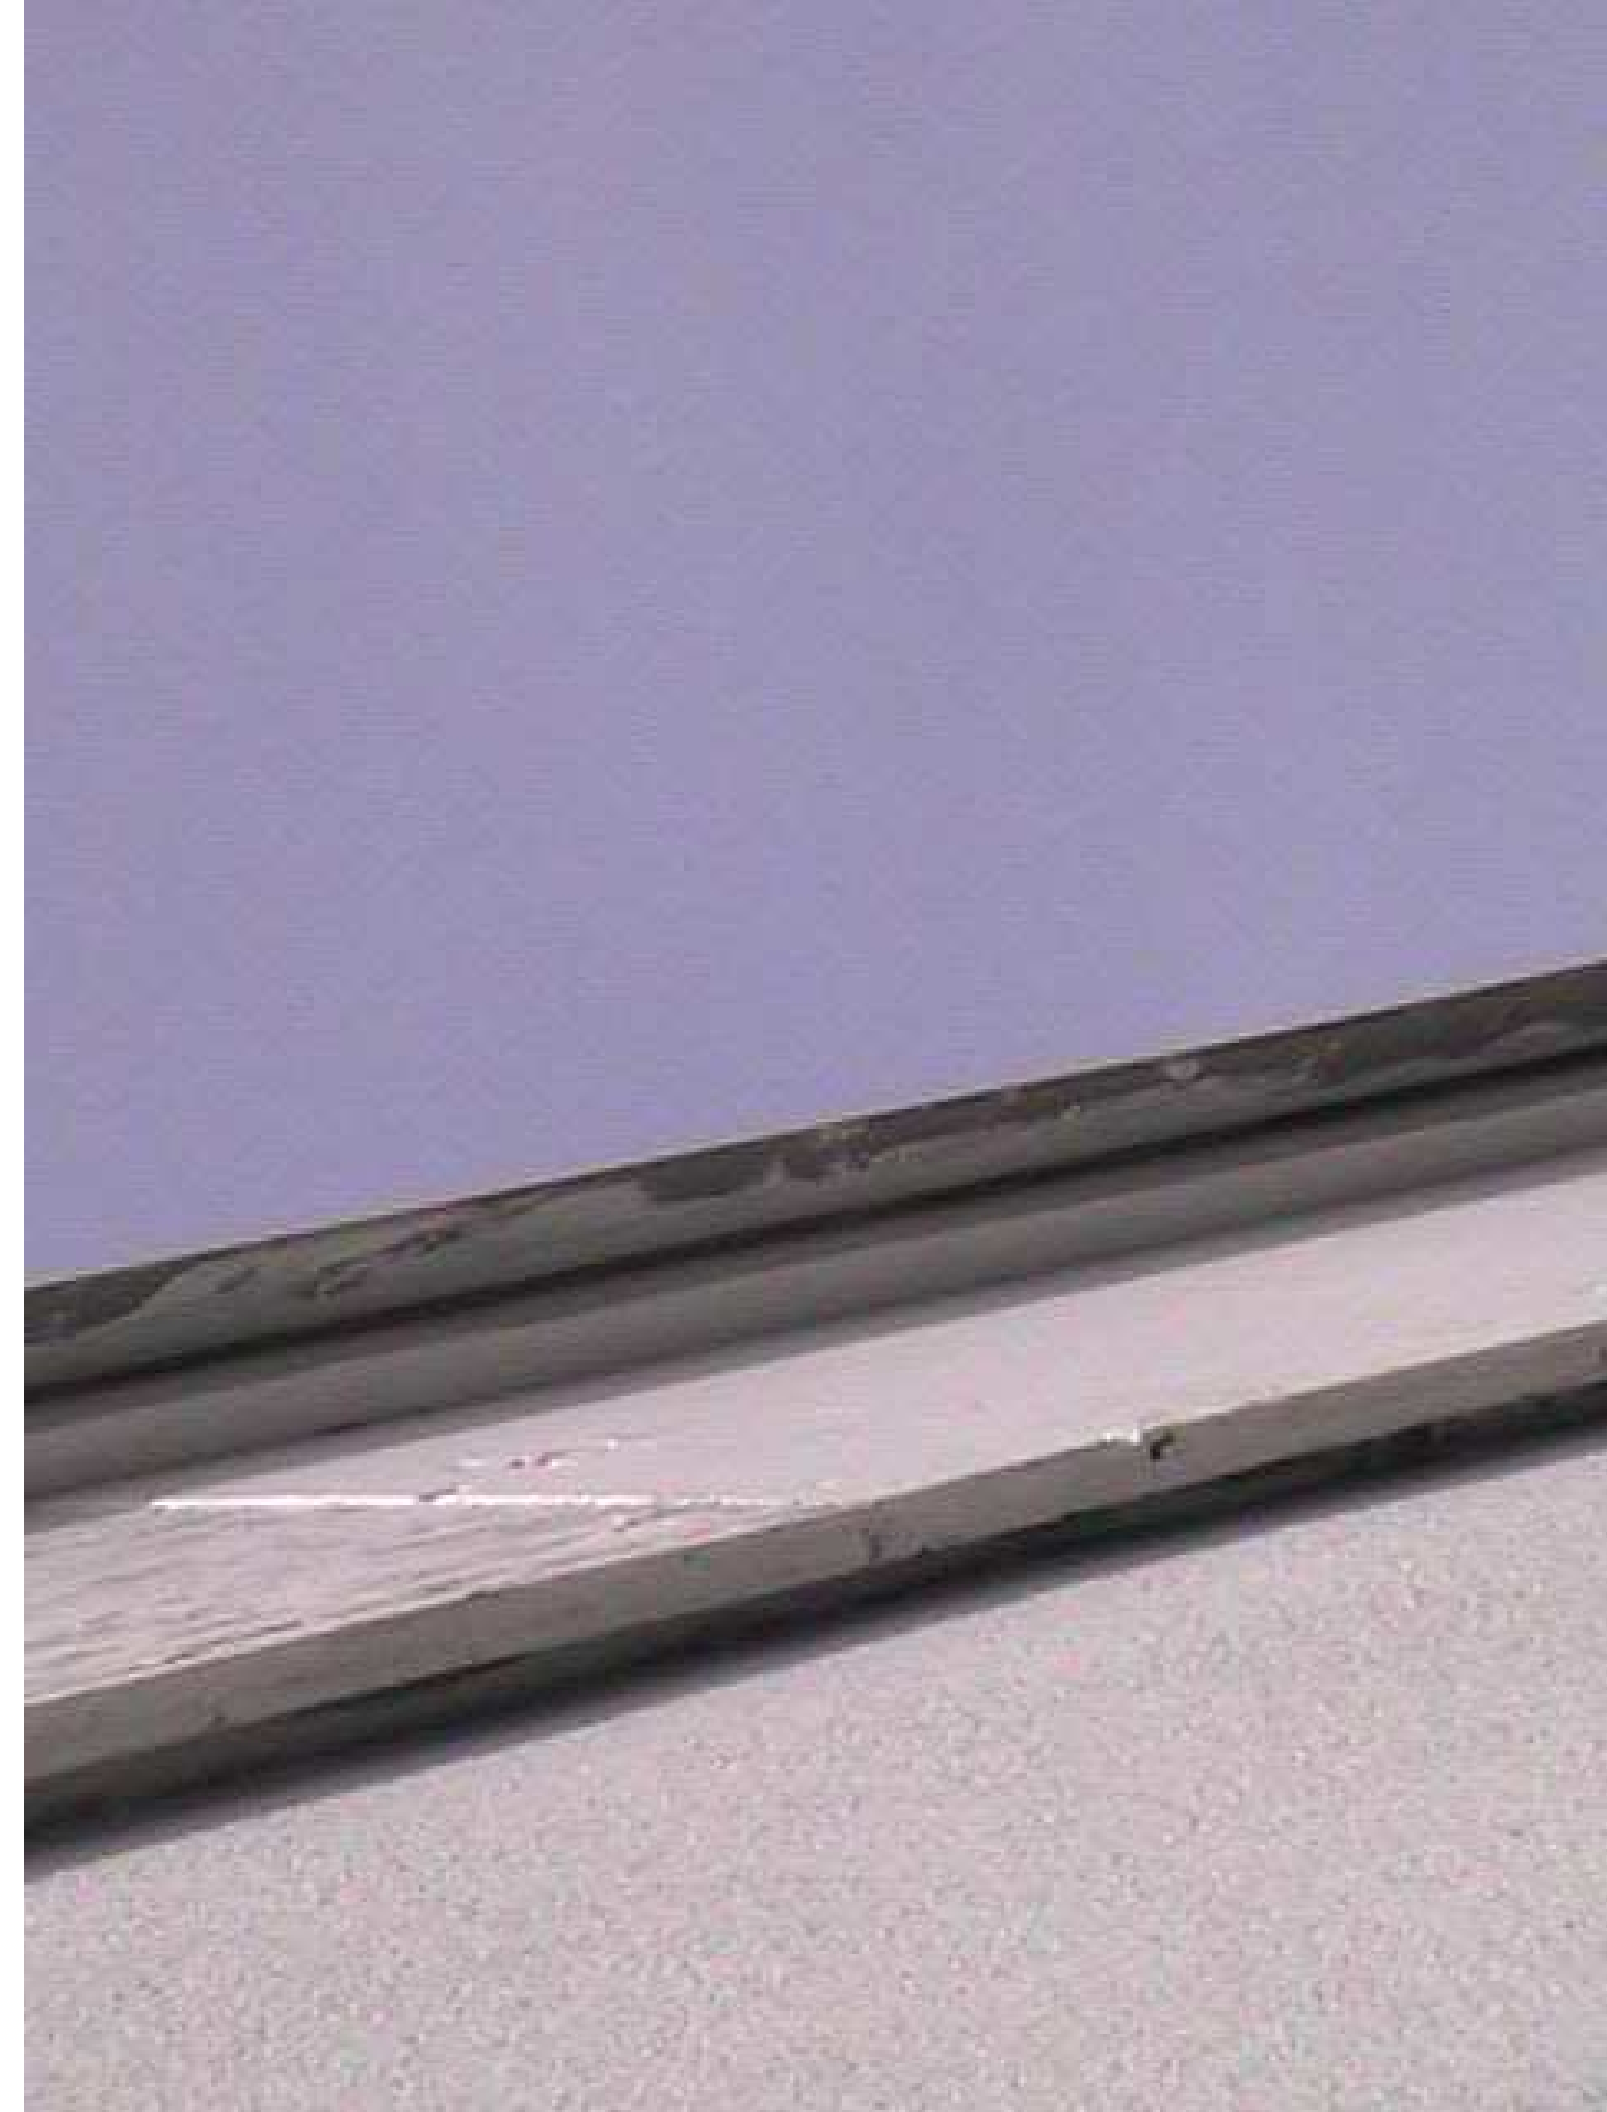
No more wall stains or damage.

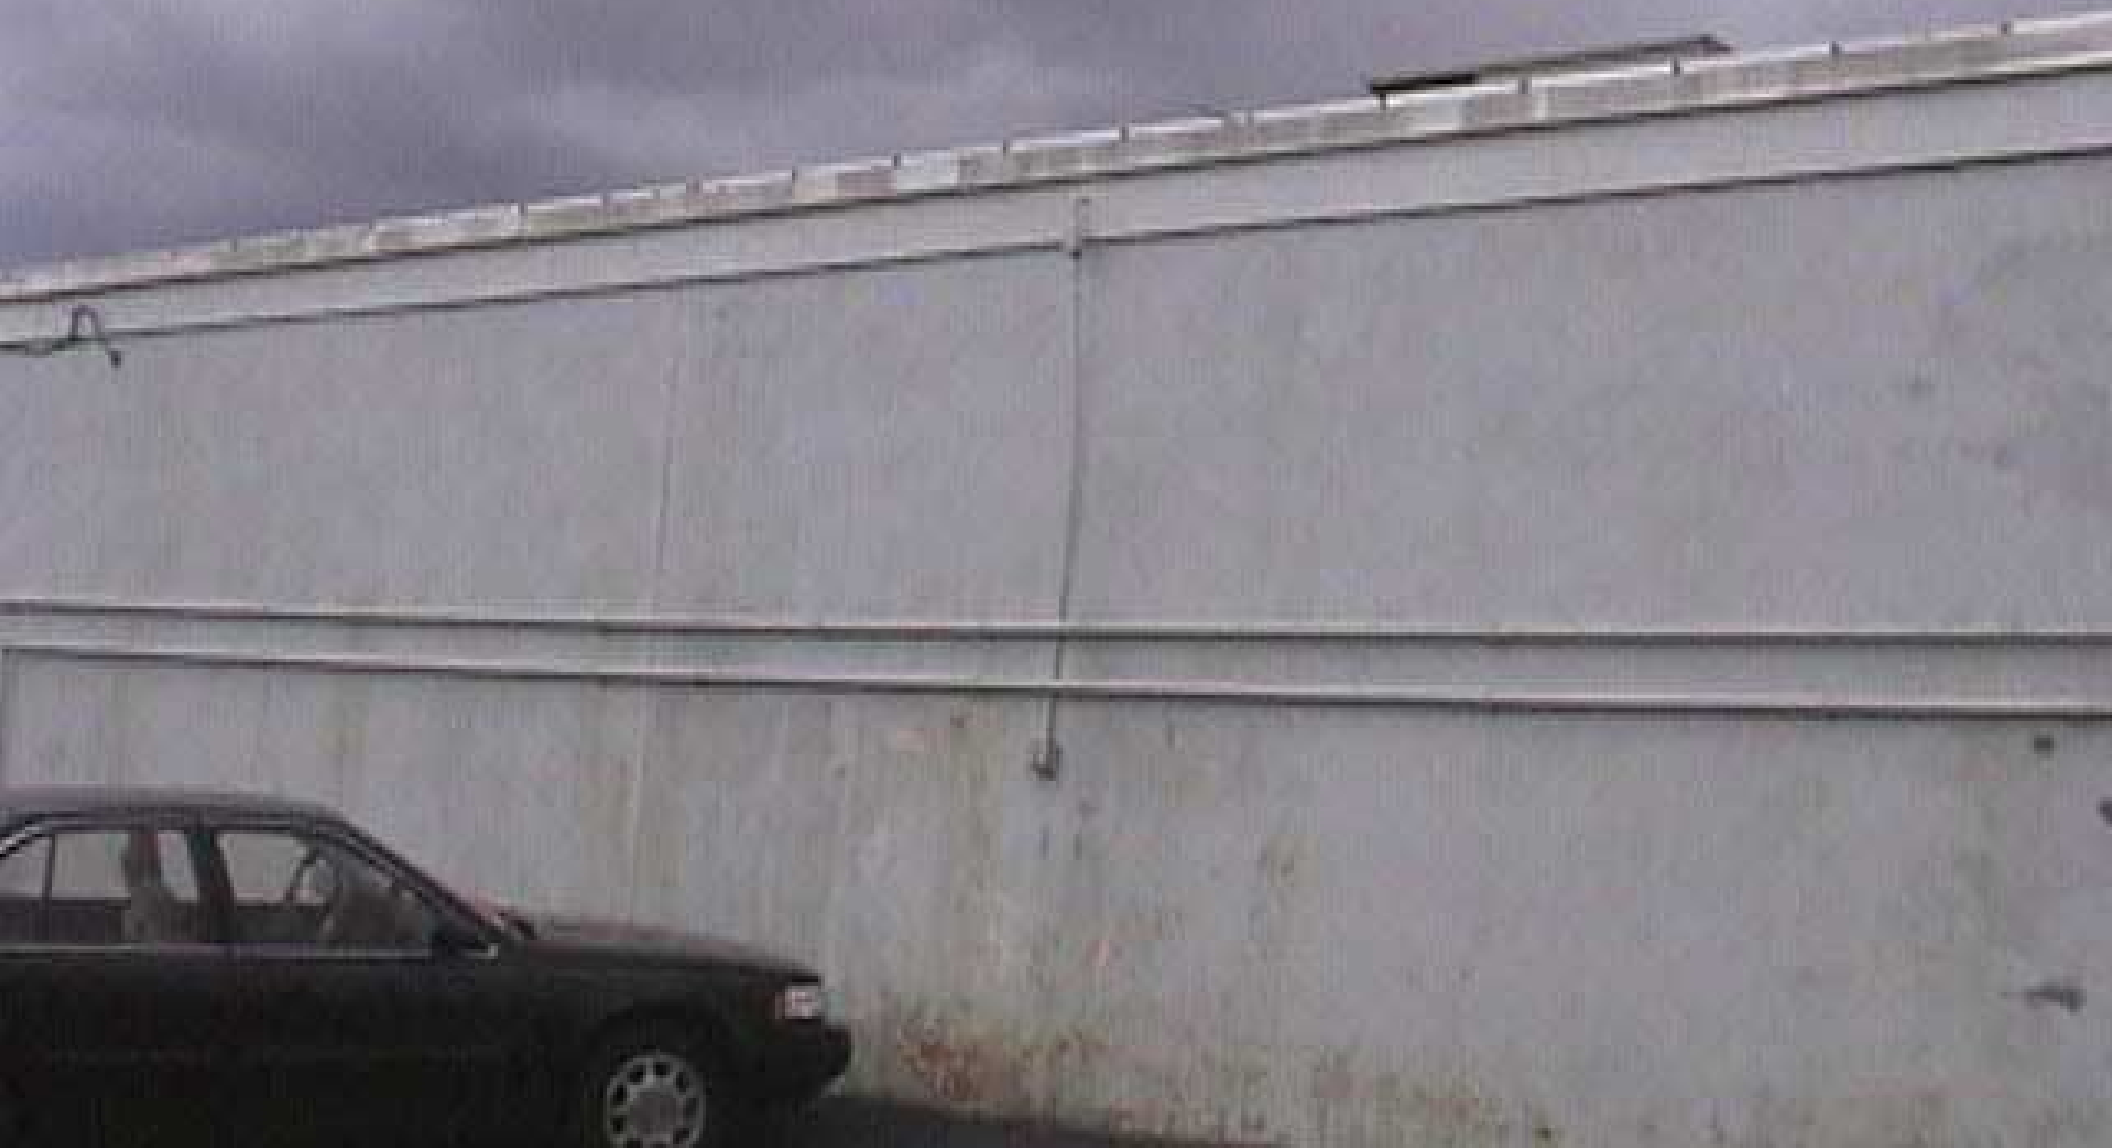
The .050 heavy duty aluminum drip edge give the building a straight, strong and clean look.

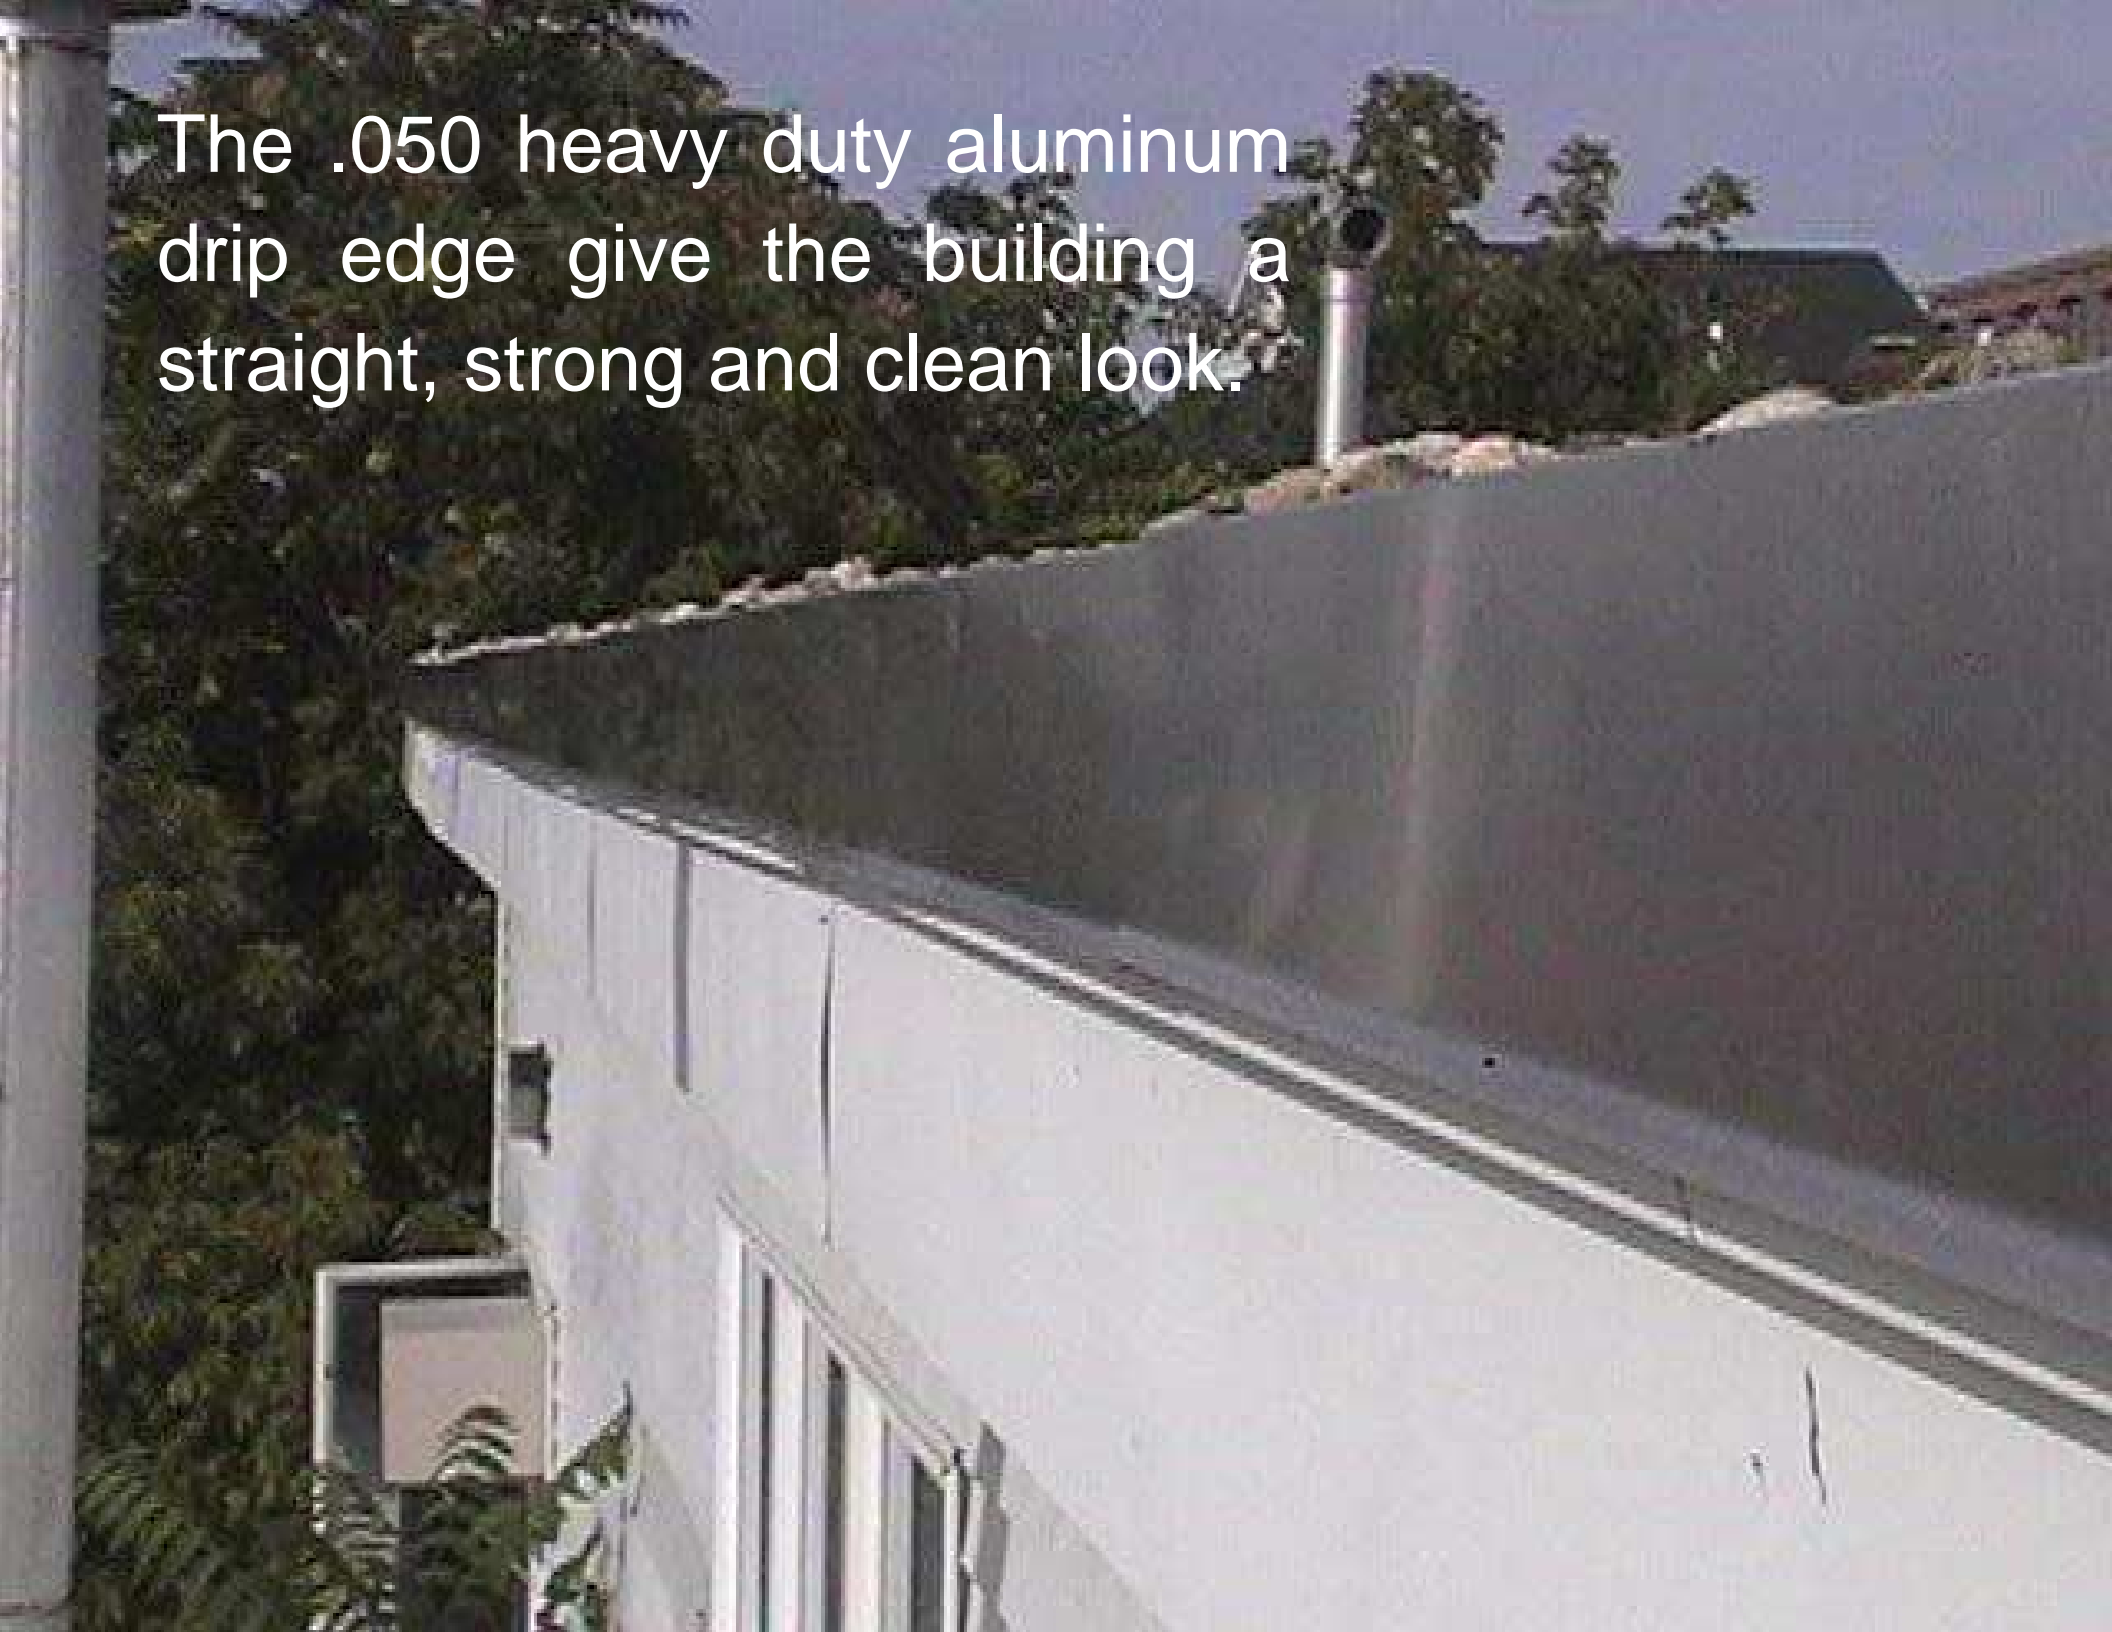
All exposed flashing was coated with
Bluestone Super Duty Aluminum Paint.
